CONSIDERATIONS REGARDING MAIN WATER PIPELINES MONITORING FOR THE PURPOSE OF LIMITING WATER LOSS

Ștefania CHIRICA¹, Mihail LUCA² and Iustina LATEȘ¹

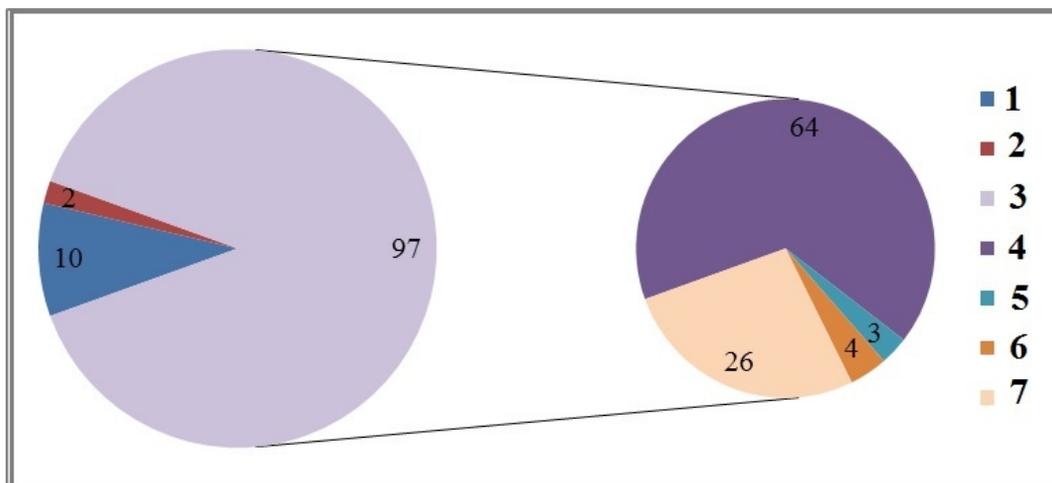
- the main factor that leads to water loss is the degradation of the pipes or tubes joints (uncoupling of the cast iron and concrete tubes, cracking of the sockets, expulsion of the sealing rings from the socket, failure of the welds on the steel sections); the research highlighted 97 events of this type out of the total of 109 analysed;

Figure 3. Main failure types registered on Timișești – Iași AdI adduction pipe; 1 – material expulsion; 2 – valves failure; 3 – damaged joints; 4 – damaged couplings on cast iron pipes; 5 – damaged couplings on PREMO pipes; 6 - failure of steel pipes welds; 7 – failure of joints in concrete pipes [13]

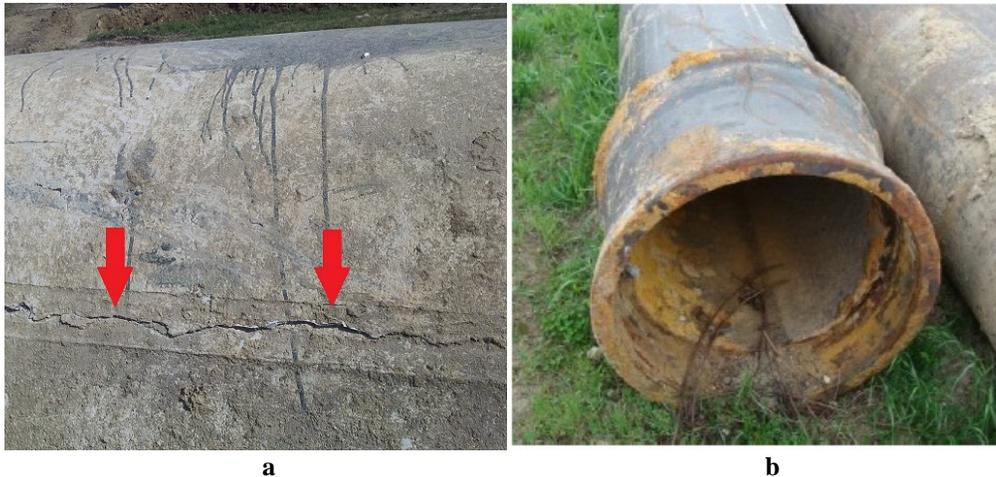
- ductile cast iron tubes are the most exposed to degradation factors through uncoupling and degradation of sealing rings in sloping embedding environments with drift potential and frequent seismic activity (Figure 4b); the analysis has highlighted that about 65% of the cases studied are ductile cast iron joints failures, amounting to 58% of the total damage recorded;
- the steel sections of the main water supply pipe are exposed to chemical corrosion caused by the external environment but also internally; the analysis revealed phenomena of structural failure of pipes and welds (4 cases out of 109, representing 3%);
- concrete tubes with sockets, fitted in the main water supply pipe (Figure 4a), show frequent cracks and breaks of the socket area (23% of cases), and their remediation is difficult due the embedding conditions of the adduction pipe;

Figure 4. AdI main water supply pipe failure mechanisms; a – cracks on reinforced concrete pipe with 800 mm diameter [13]; b – damaged socket on cast iron tubes with 600 mm diameter [14]

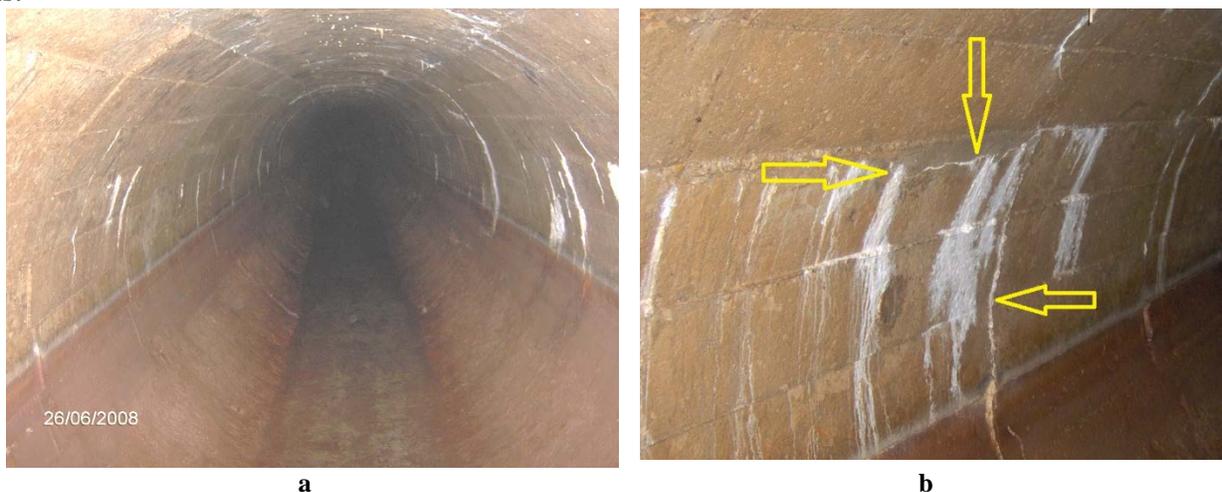
Figure 5. Failure types on Strunga hydro technical gallery located on Timișești - Iași AdII adduction pipe; a – general view of the flow section made of reinforced concrete; b – details on the existence of horizontal and vertical micro-cracks in the concrete wall [16]

- Moldova River undercrossing area, due to the continuous action of the hydrodynamic phenomena generated by the variation of hydrological and hydraulic parameters in the river bed;
- the hydrotechnical gallery passing under Strunga Hill, where infiltration and seepage processes through the concrete wall of the gallery are present (Figure 5) [15];
- the main water supply pipe located between Sârca and Iași, where the high value of overpressure causes frequent damages on some pipe sections.
