5th WATER LOSS
Balkans Forum and
Exhibition

MONITORIZAREA REȚELELOR DE DISTRIBUȚIE APĂ PENTRU
DEPISTAREA PIERDERILOR DE APĂ FOLOSIND LOGGERII DE
ZGOMOT HWM PERMANENT SU, PRIN TEHNICA
LIFT & SHIFT

S T U D I I D E C A Z :
A q u a t i m T i m i ș o a r a ș i A p a s e r v S a t u M a r e

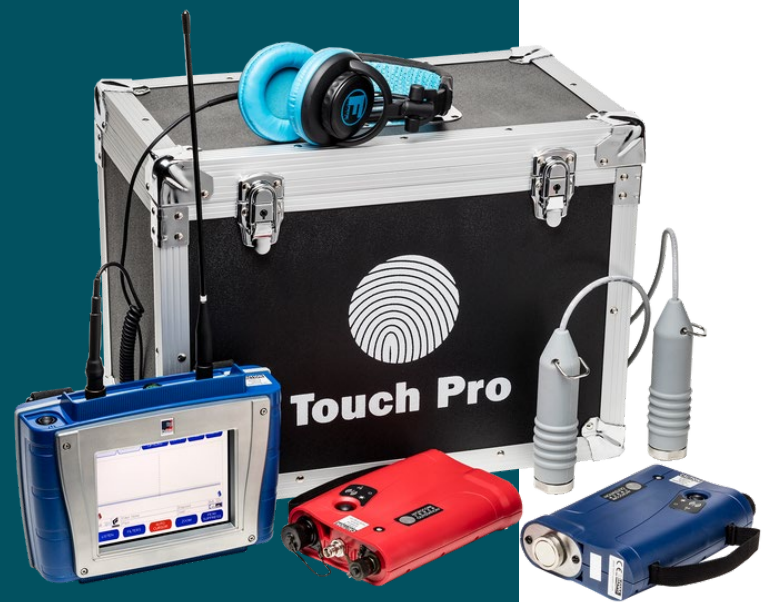
CORELATOR DE TEREN - TOUCH PRO

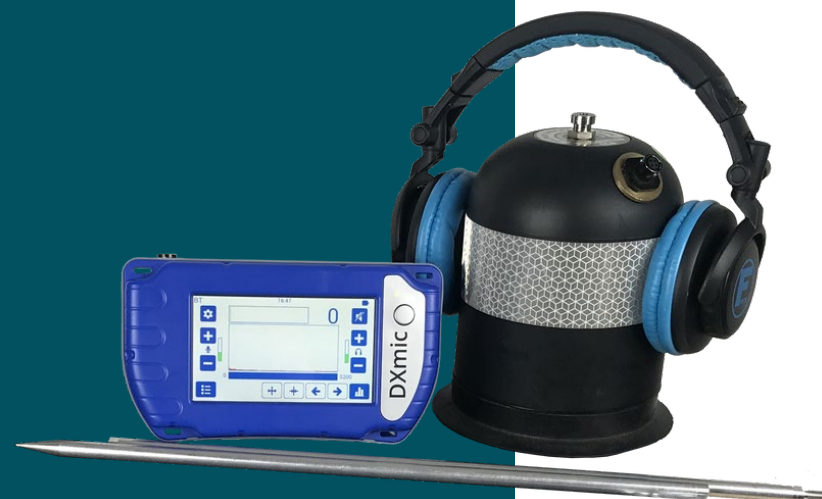
MICROFON DE SOL - DX MIC

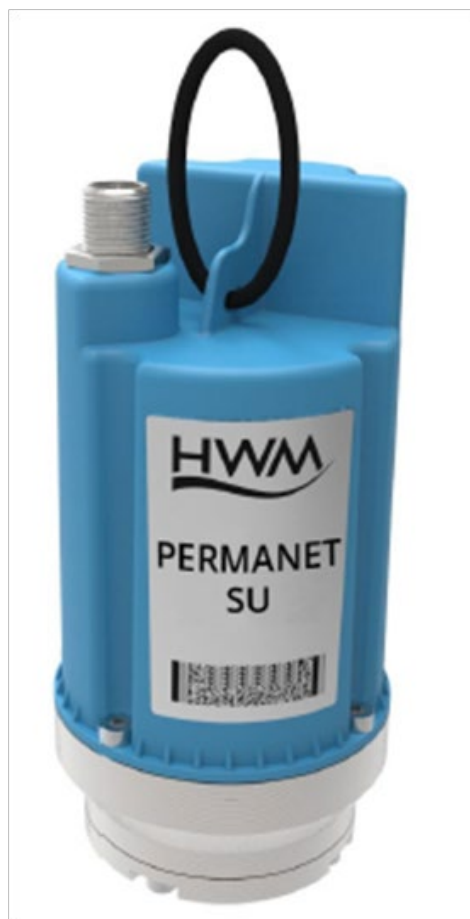
PERMANET SU

IP 68

MODEM NBIOT, LTE - CAT M1
GPRS- 2G, 3G, 4G, SMS

BLUETOOTH BLE 5.0

COMUNICATIE BIDIRECTIONALA

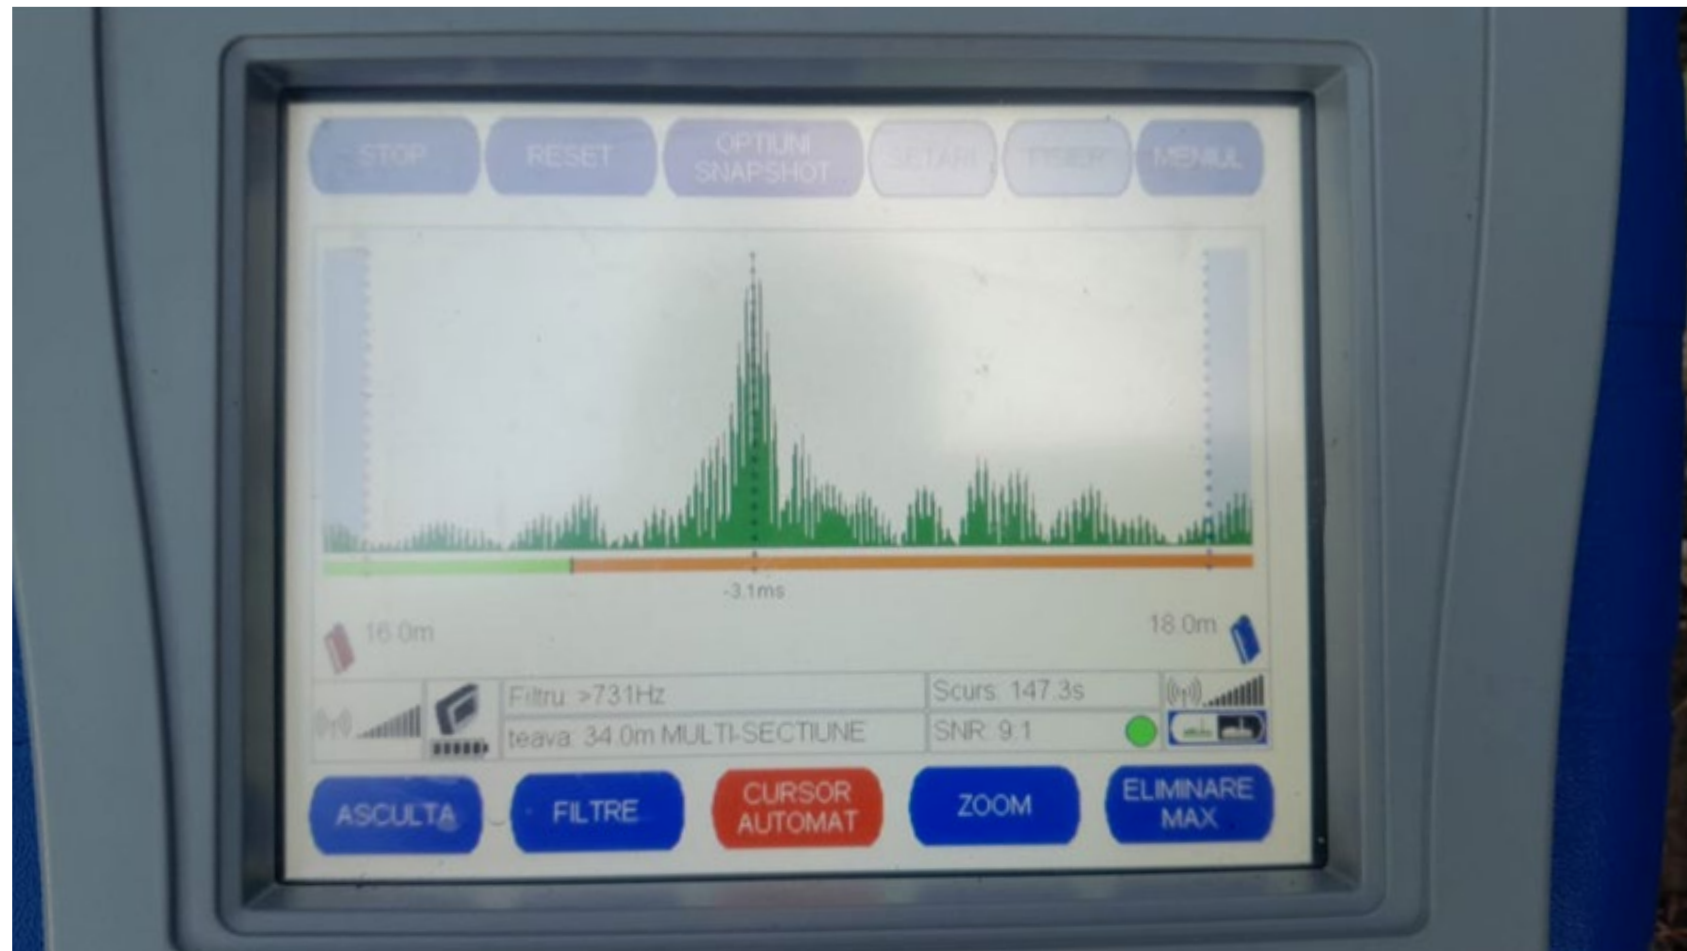
Corelator HWM

Utilizare corelator HWM

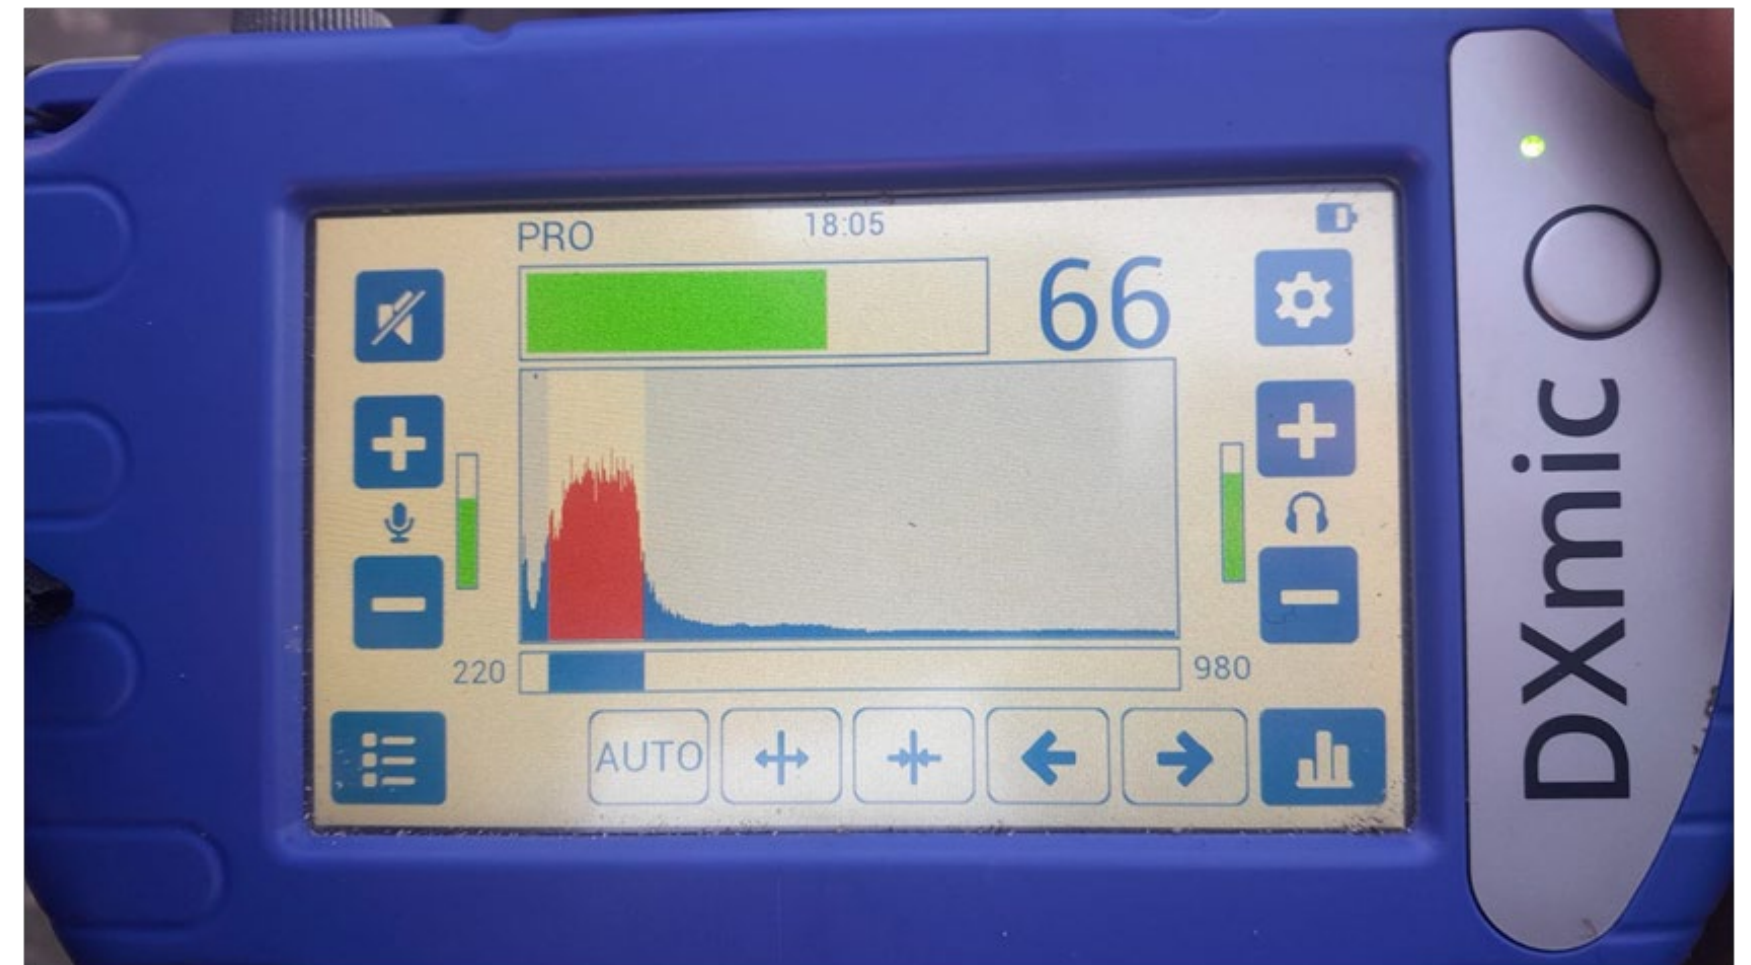
Microfon HWM

Utilizare microfon de sol HWM

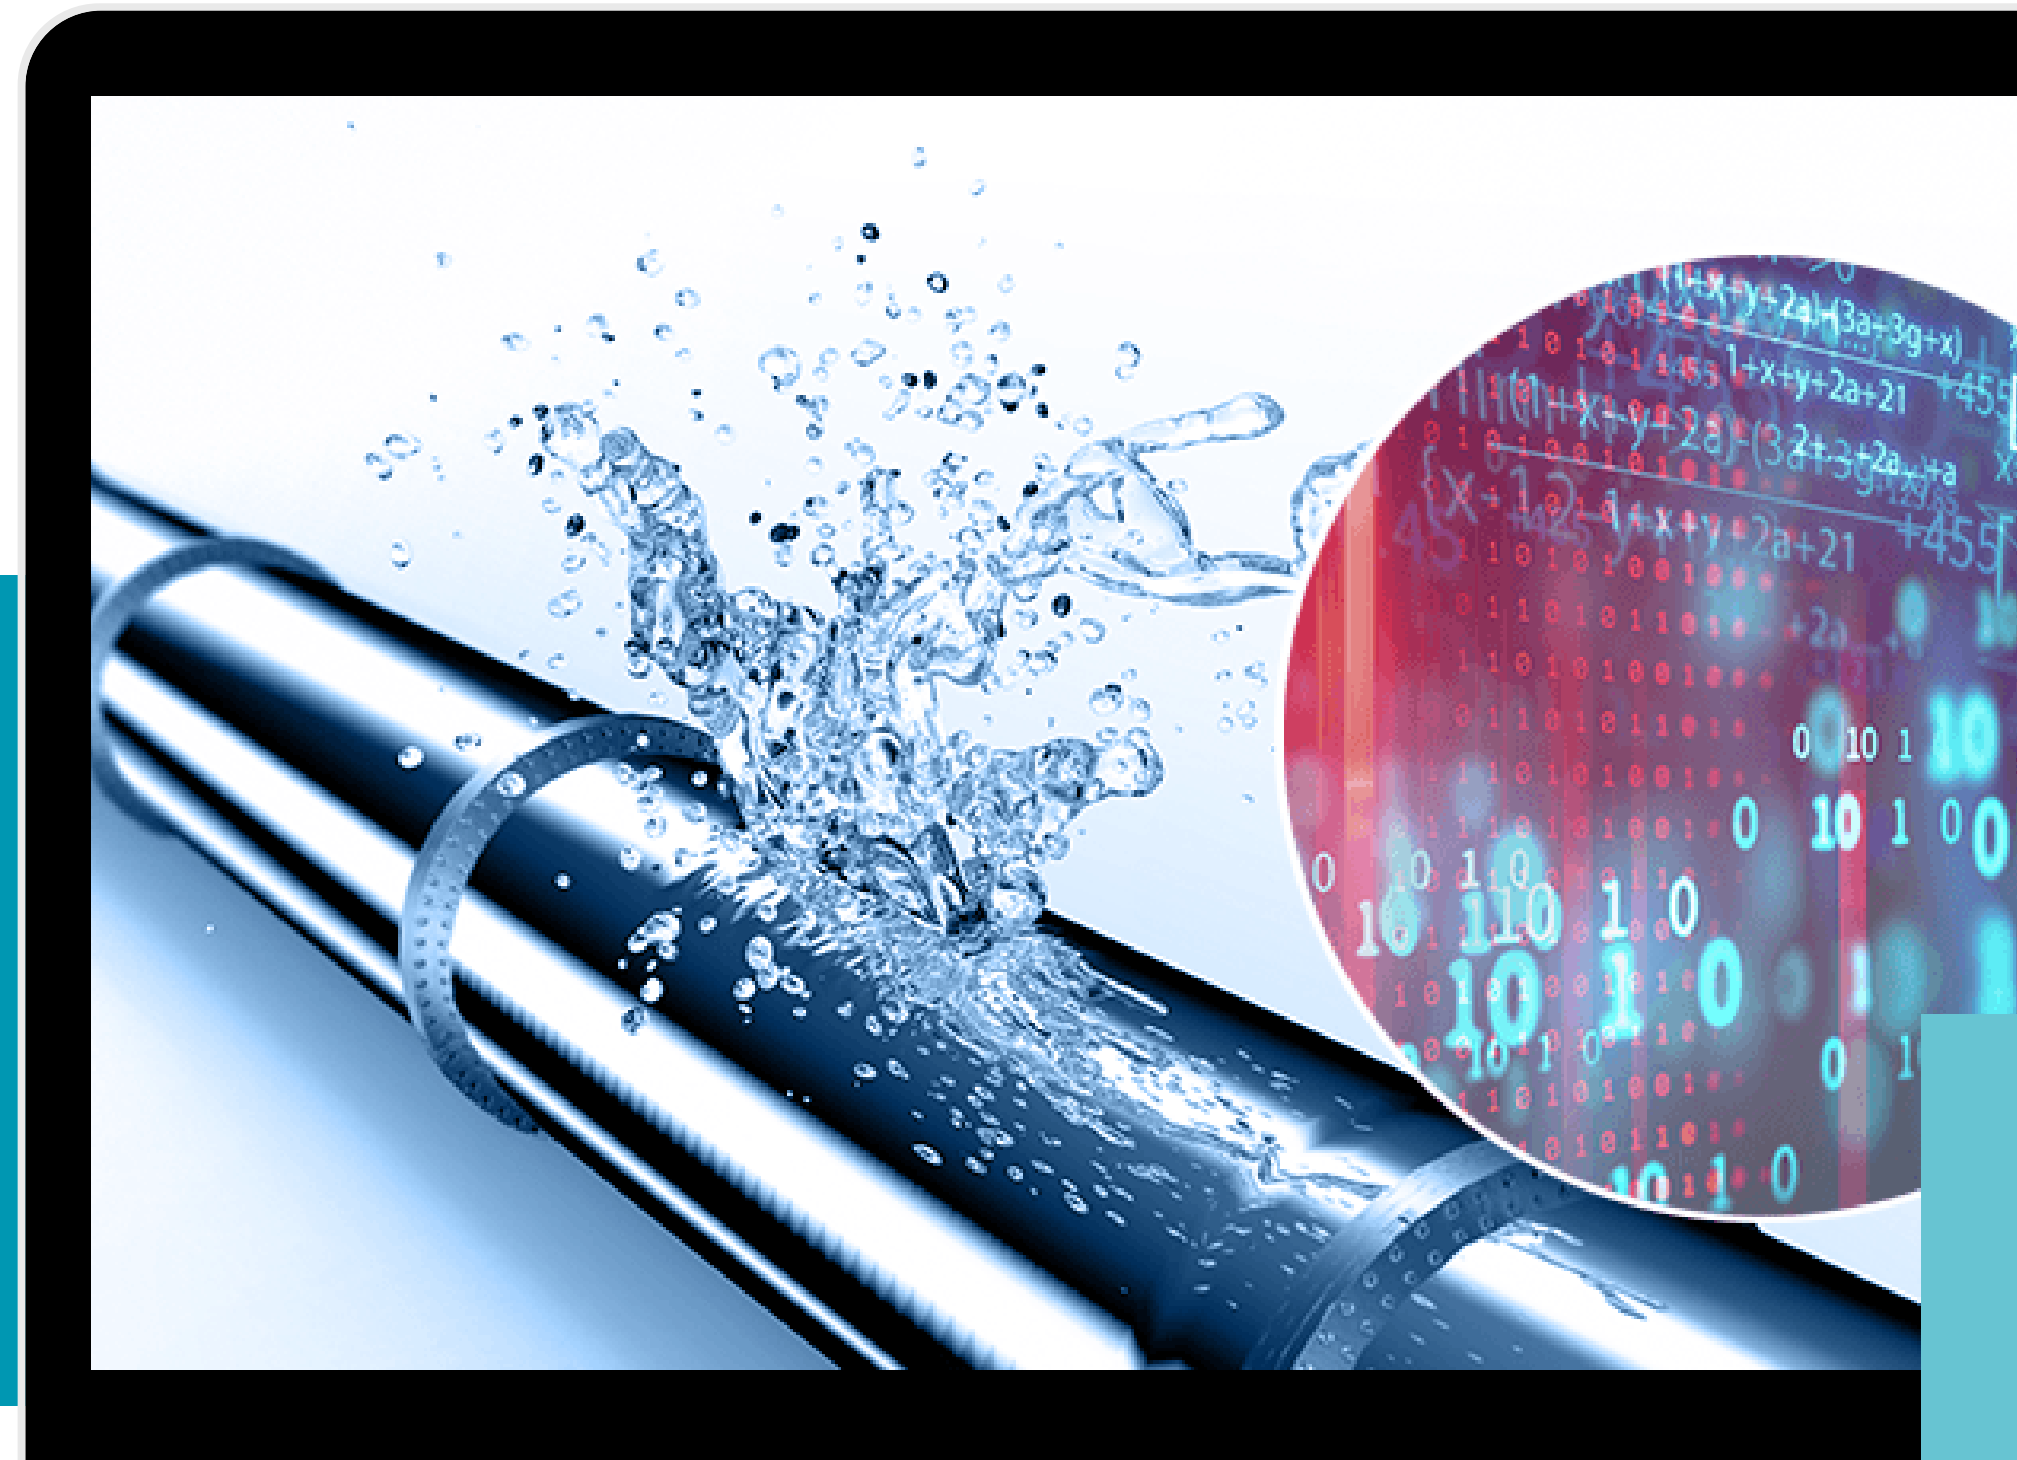
MONITORIZARE DEBIT NOCTURN PLECARE ST DUMINICA 03:00

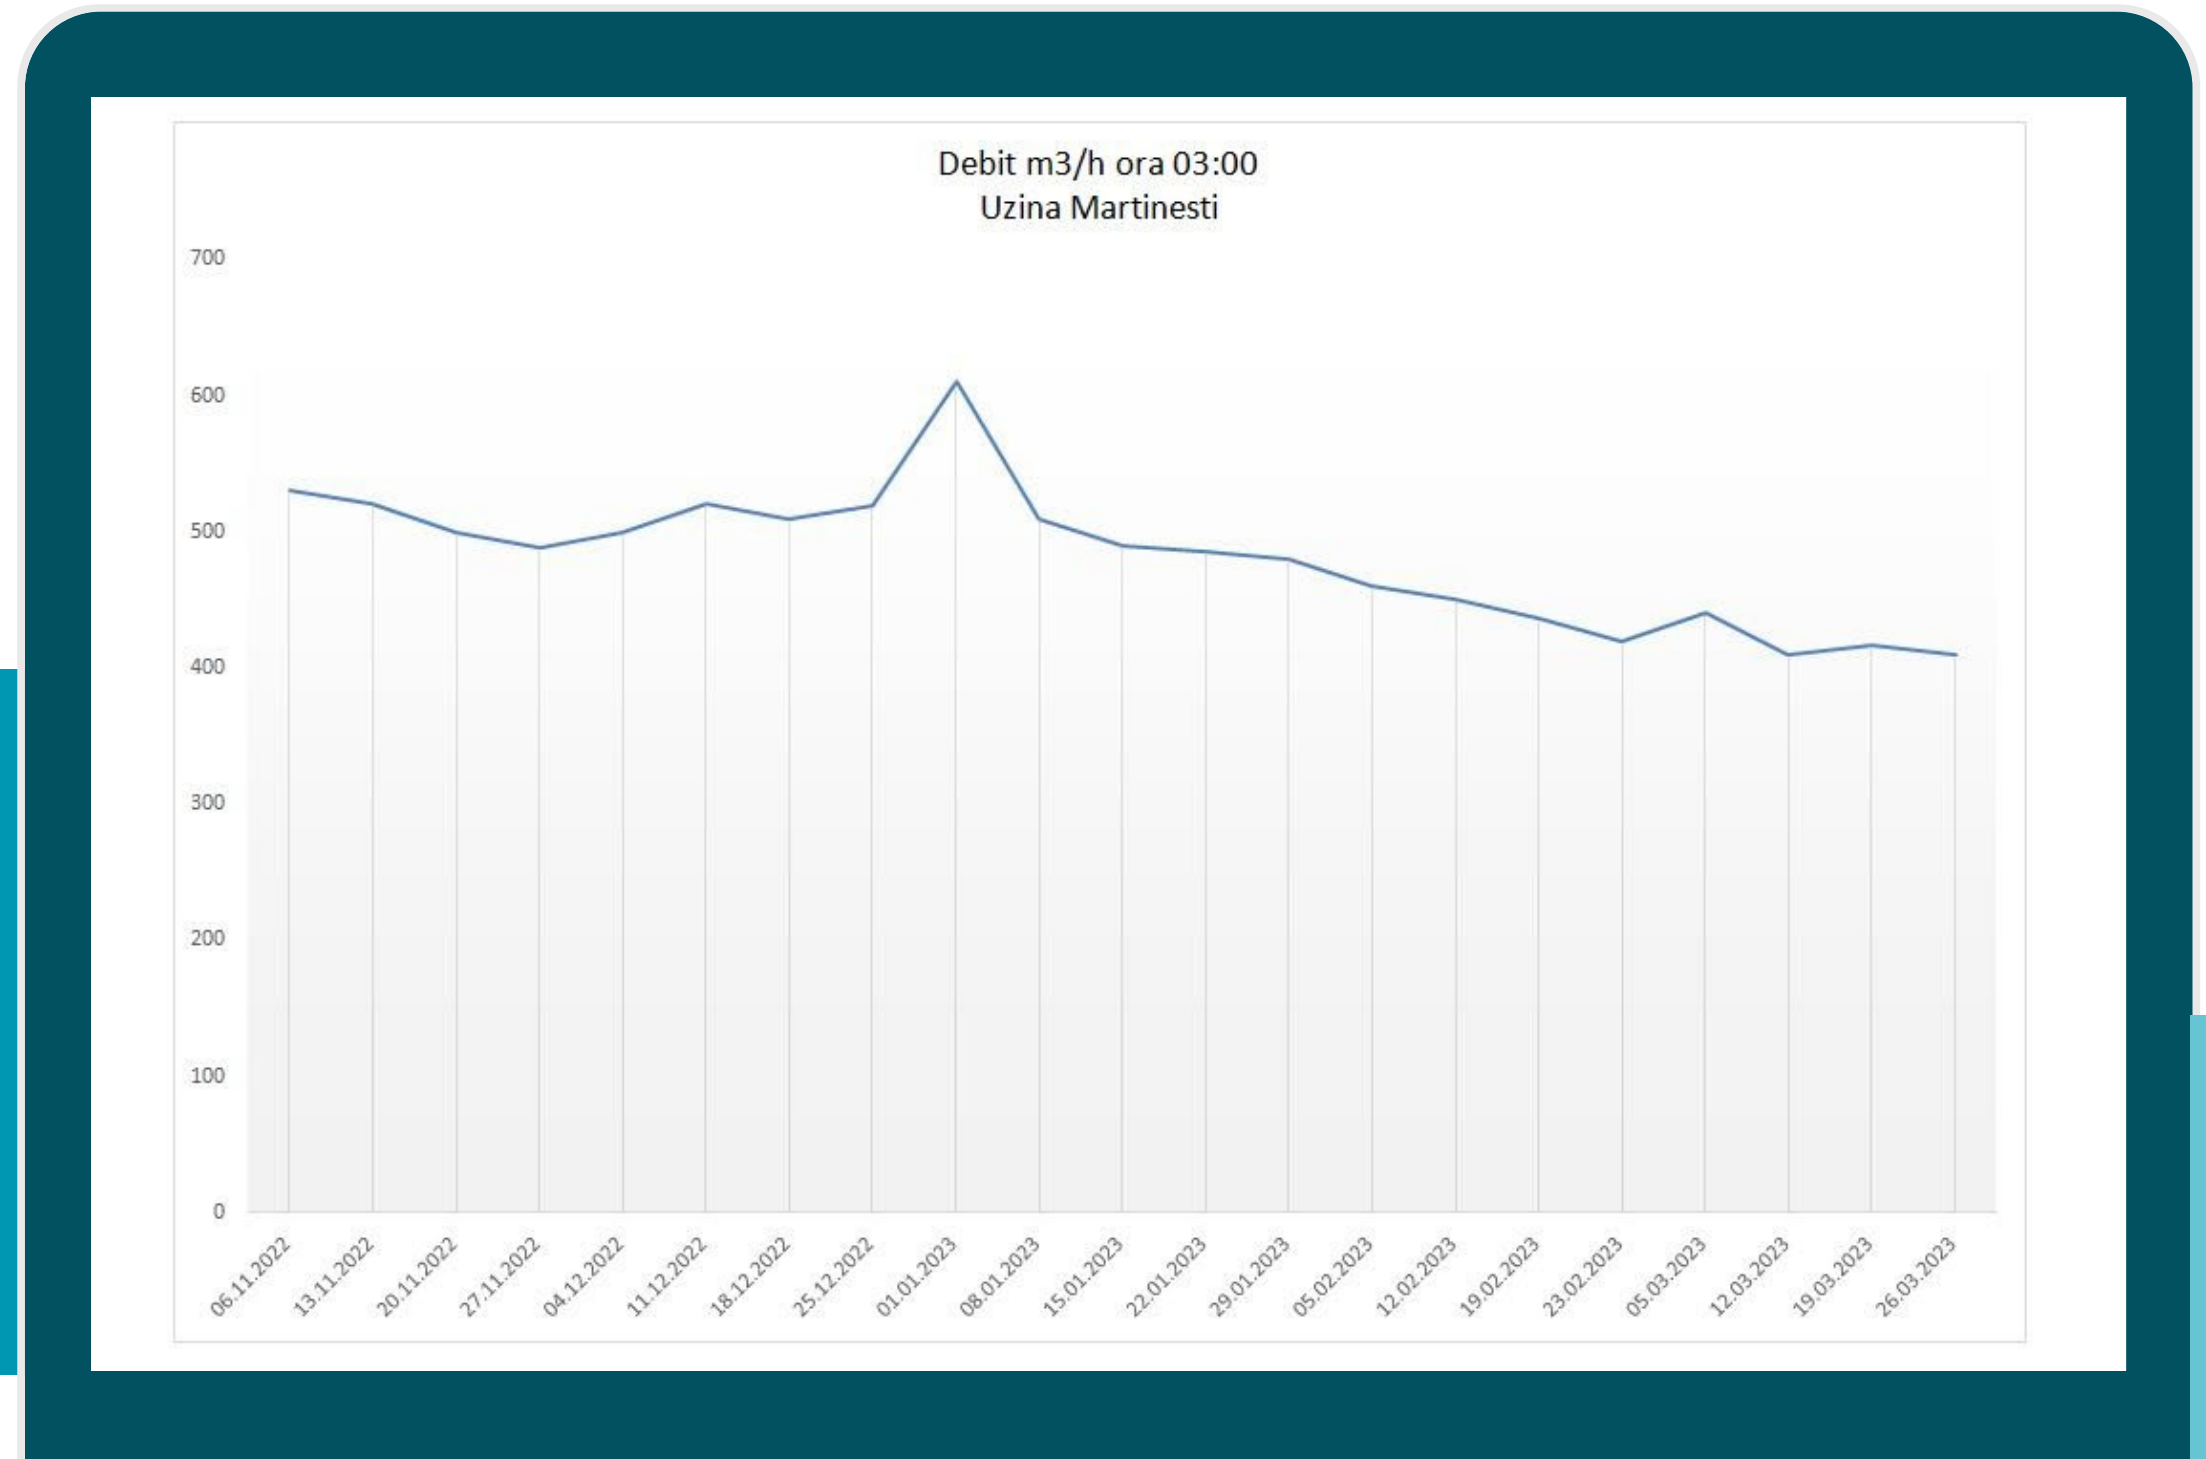
Valori initiale: 530 m³/h

Valori finale: 410 m³/h

Debit minim : 390 m³/h

(13.03.2023, 03:00)

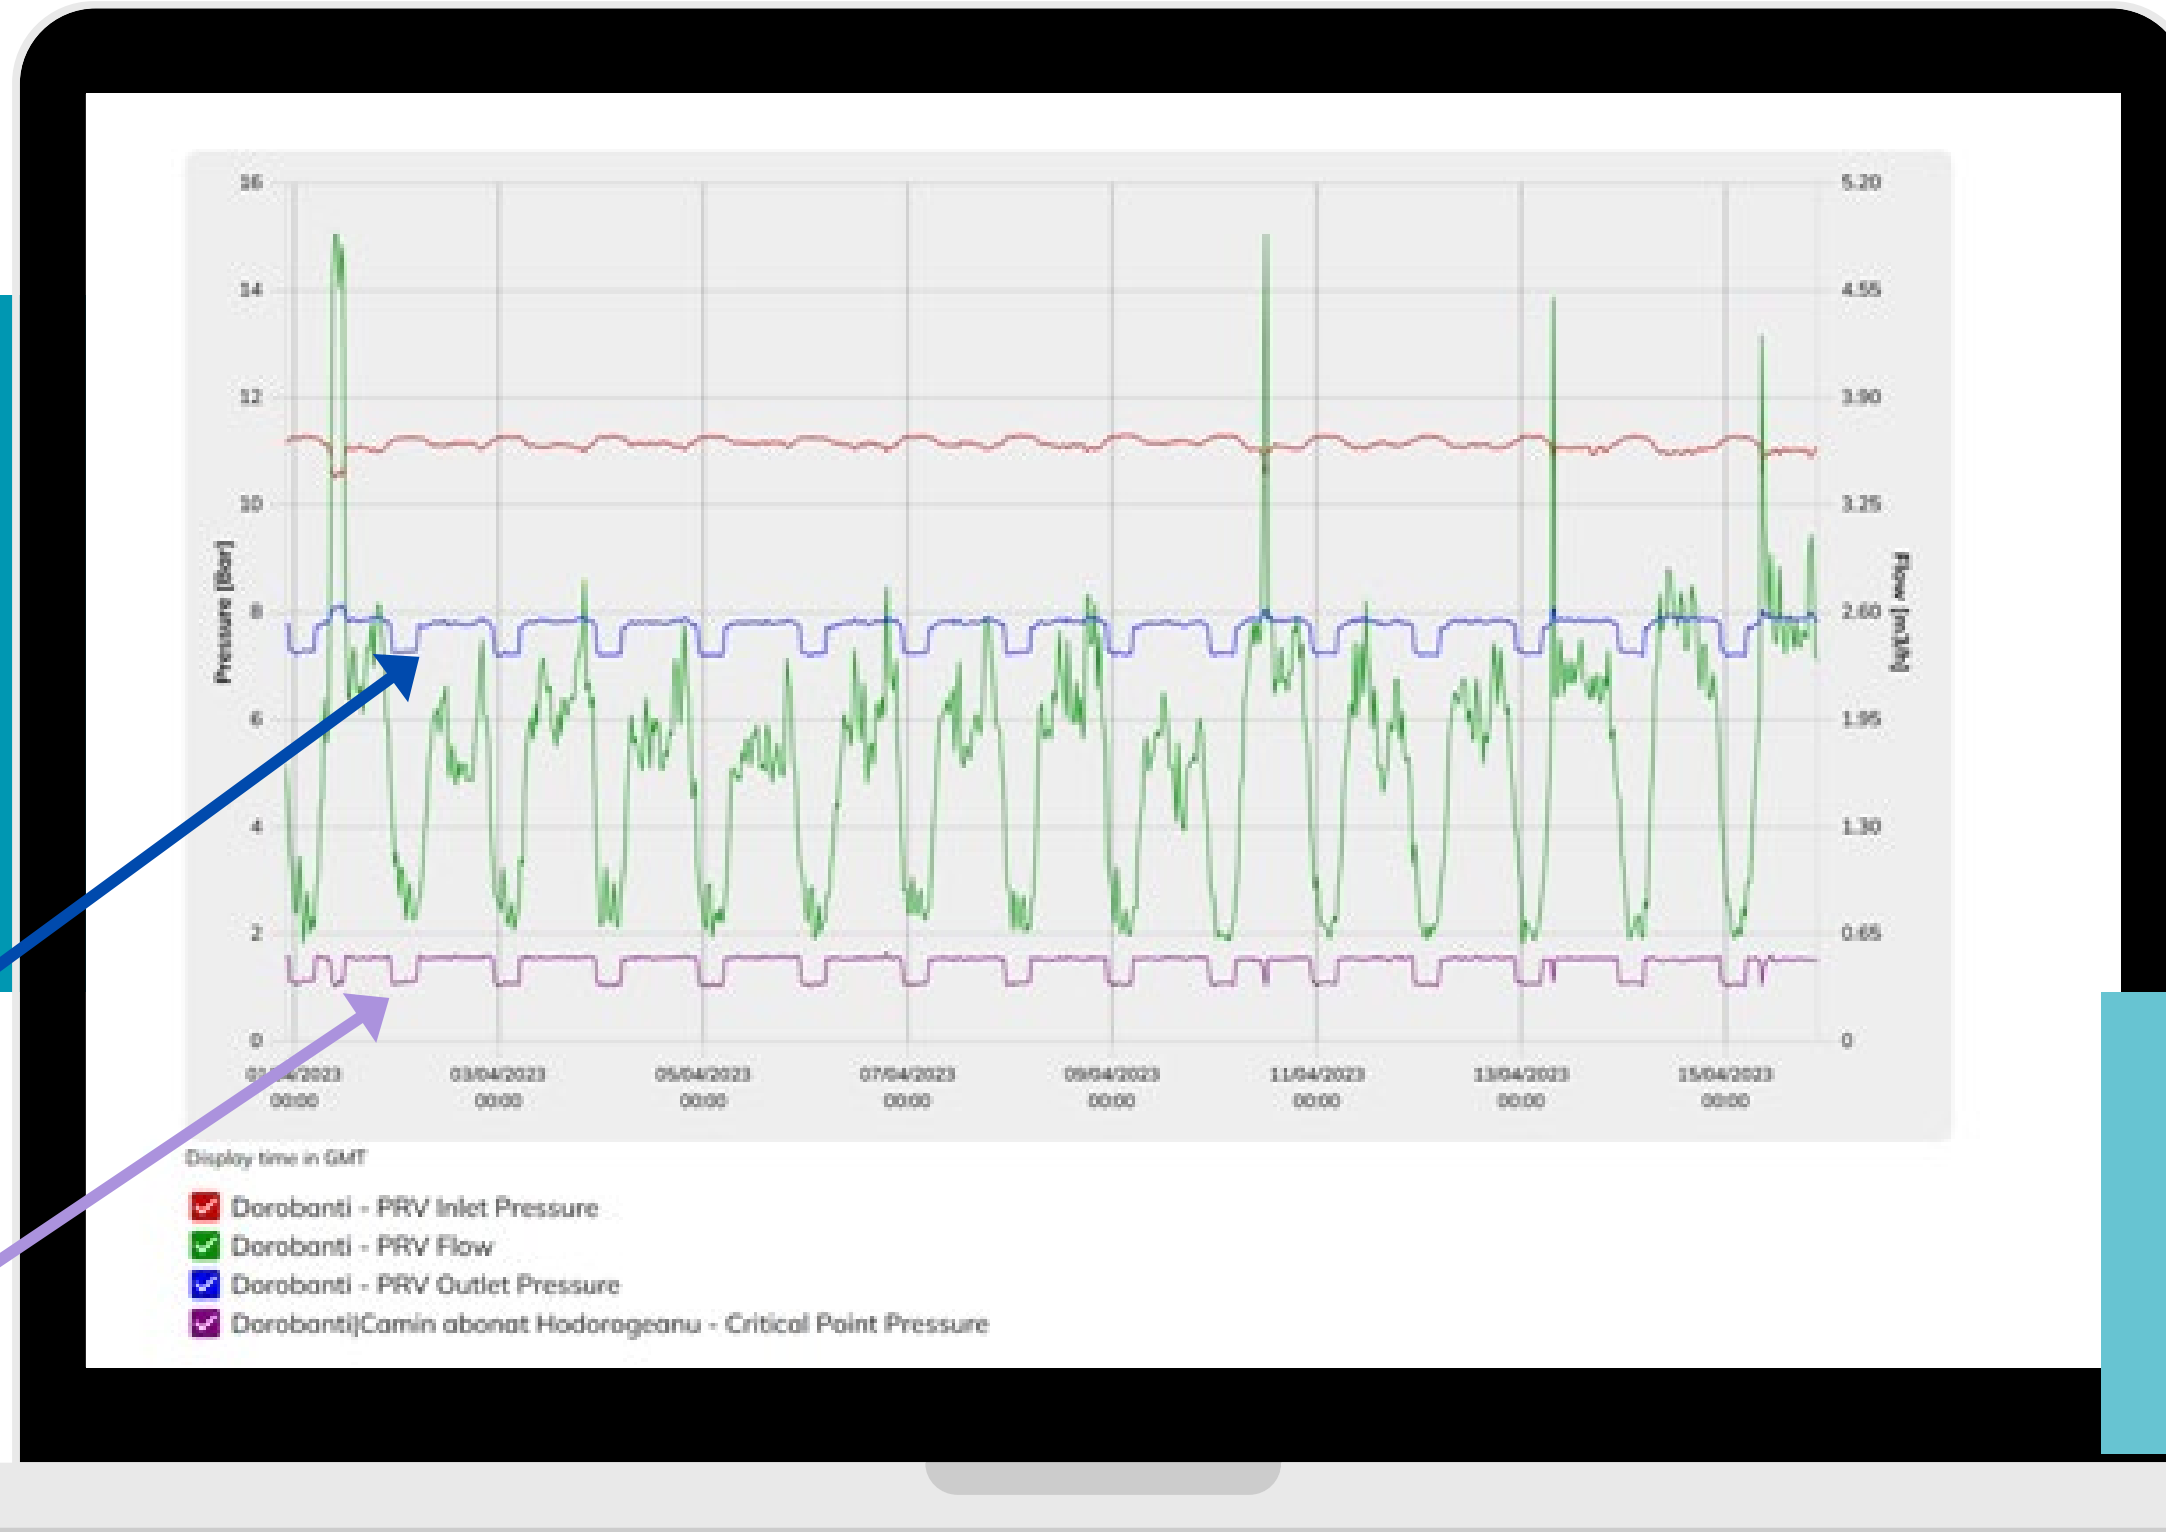
Presiune la iesire PRV,
controlata de Pegasus

Presiune in punctul critic
