# BIO TECH SRL

# Oferta de servicii si lucrari

# ASTERRA

# Success story Constanța - Romania

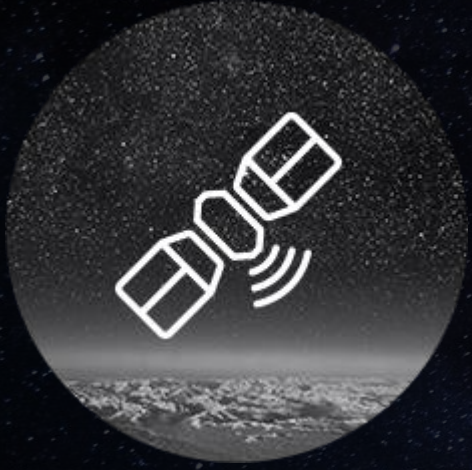
1

Obtinere imagine  
spectrala prin satelit

*Imagini brute ale zonei obtinute  
prin SAR*

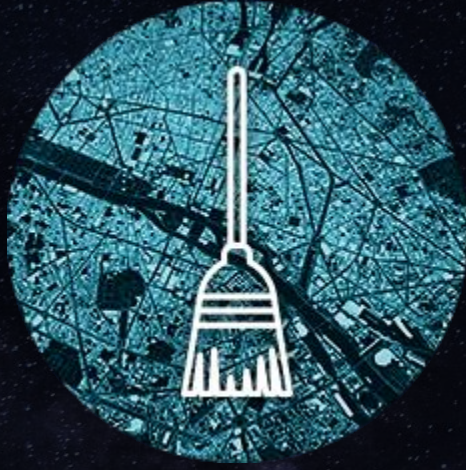
2

Corecturi  
radiometrice

*ASTERRA prelucreaza datele brute  
si le pregateste pentru analiza,  
prin reducerea zgomotului produs  
de cladiri si alte obiecte artificiale,  
vegetatie, etc.*

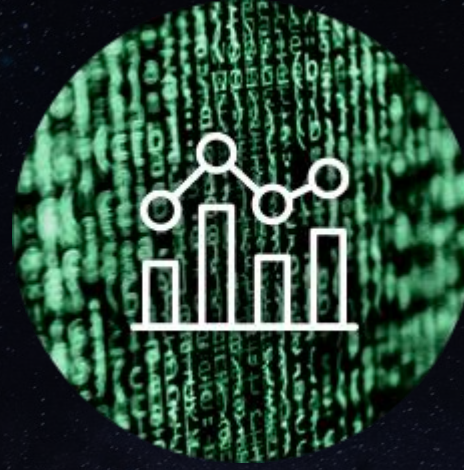
3

Analiza  
algoritmica

*Utilizand analiza algoritmica  
avansata Utilis pentru a  
identifica "semnatura"  
spectrala a apei tratate si a  
interactiunii acesteia cu solul*

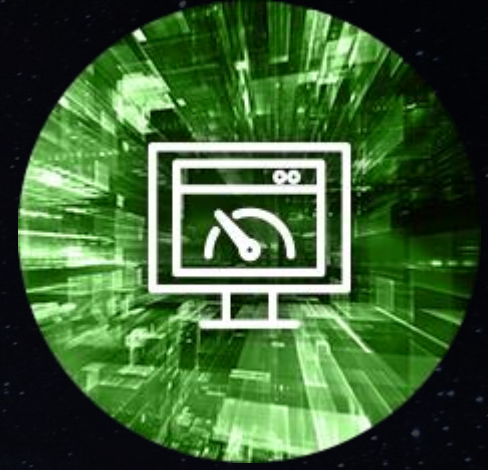
4

Rezultate

*Pierderile sunt afisate pe diverse tipuri  
explicite de interfata GIS*

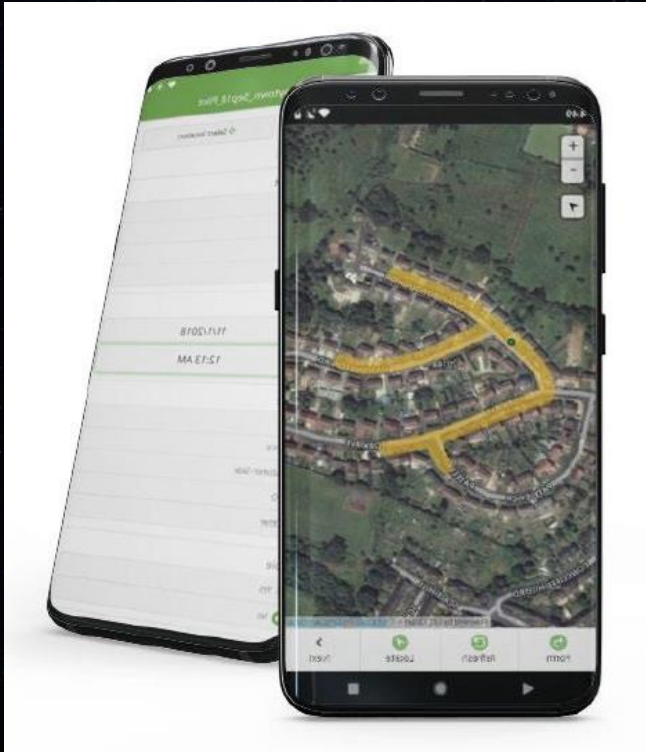
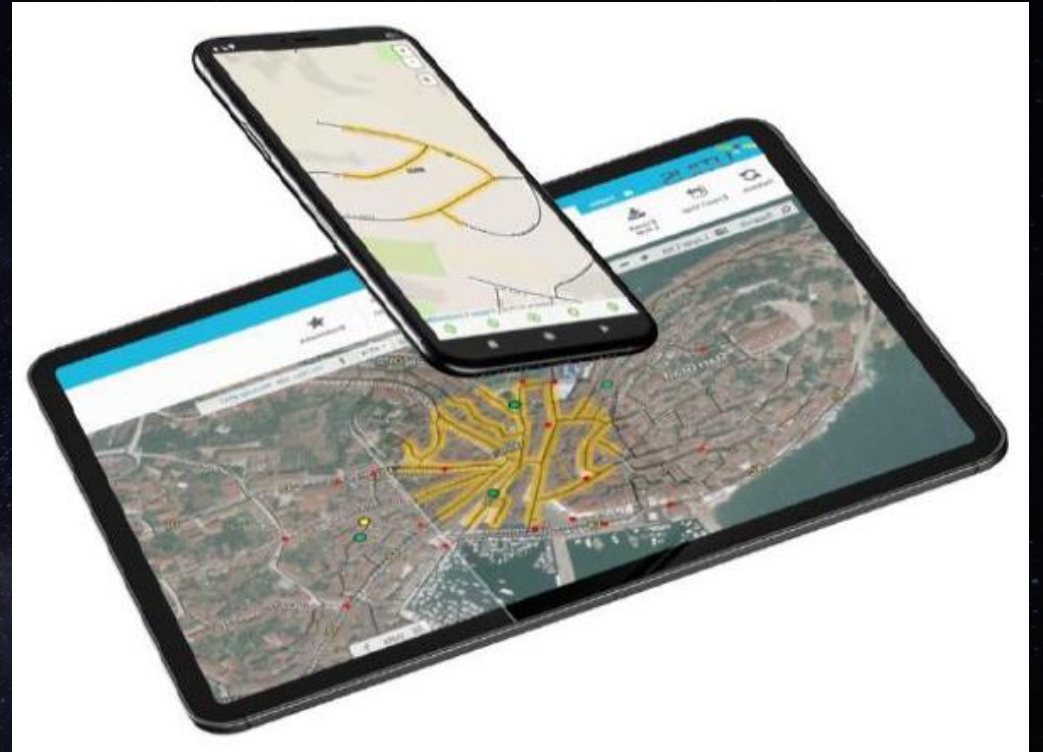
# Etapa 4: Rezultate

- ✦ Fisier SHP
- ✦ Aplicatii web U-View & U-Collect / Dashboard
- ✦ Fisa pierderi

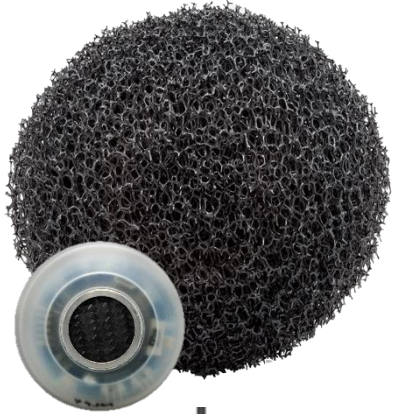
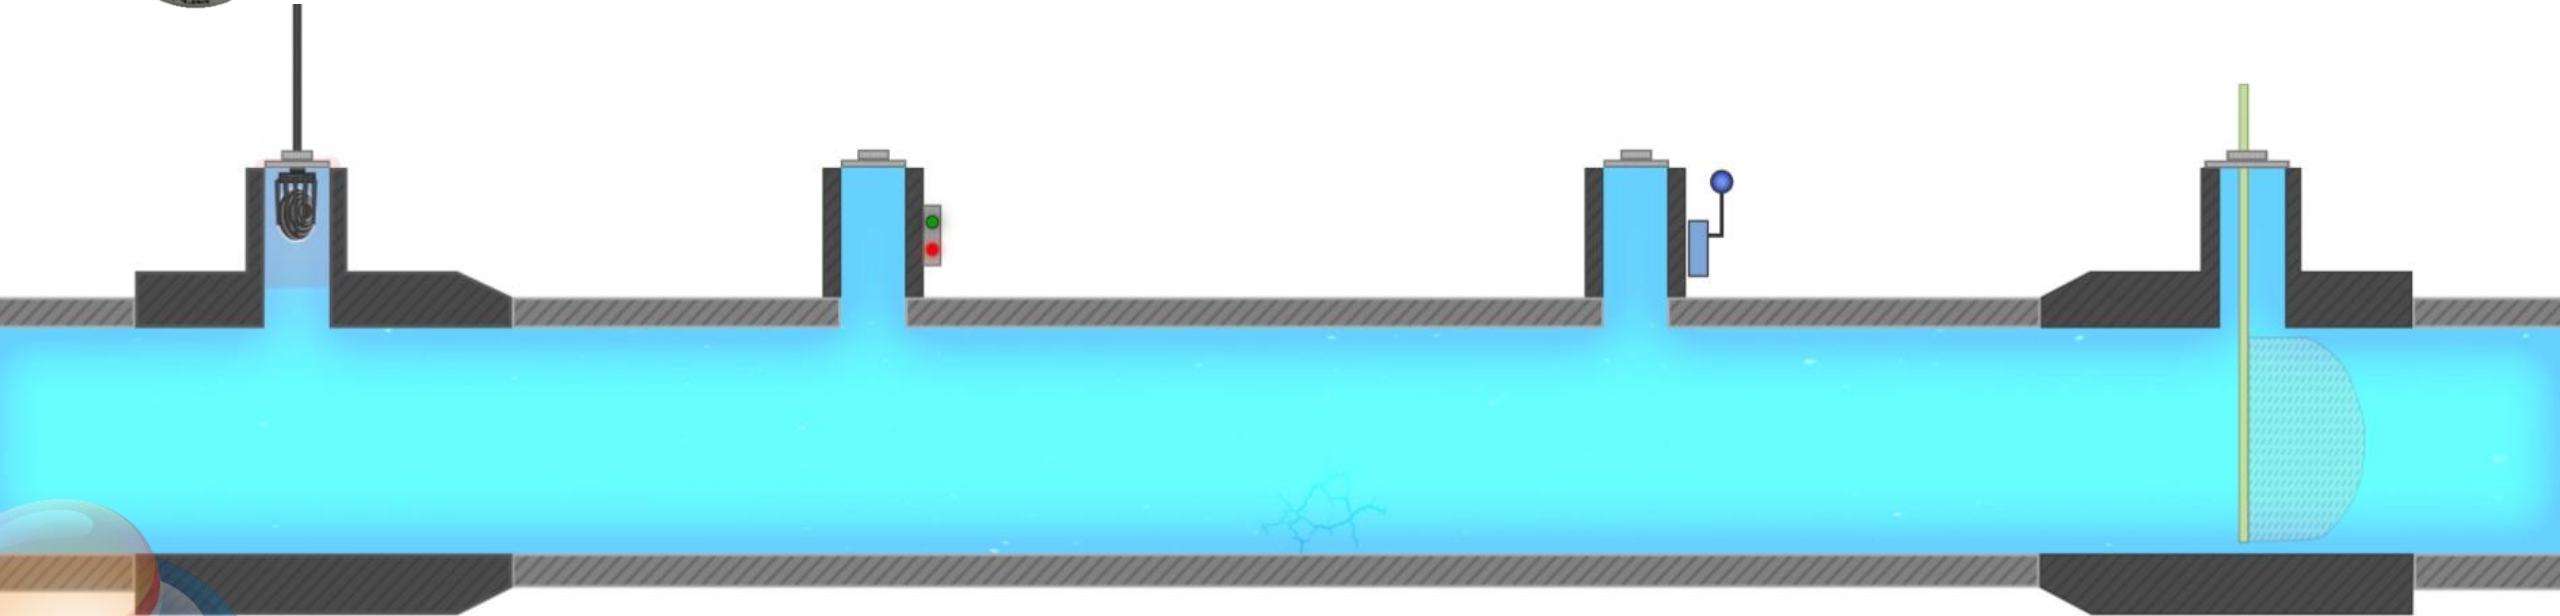
# How does it work?

## 3 PHASE INSPECTION:

1. Insertion
2. Navigation
3. Extraction

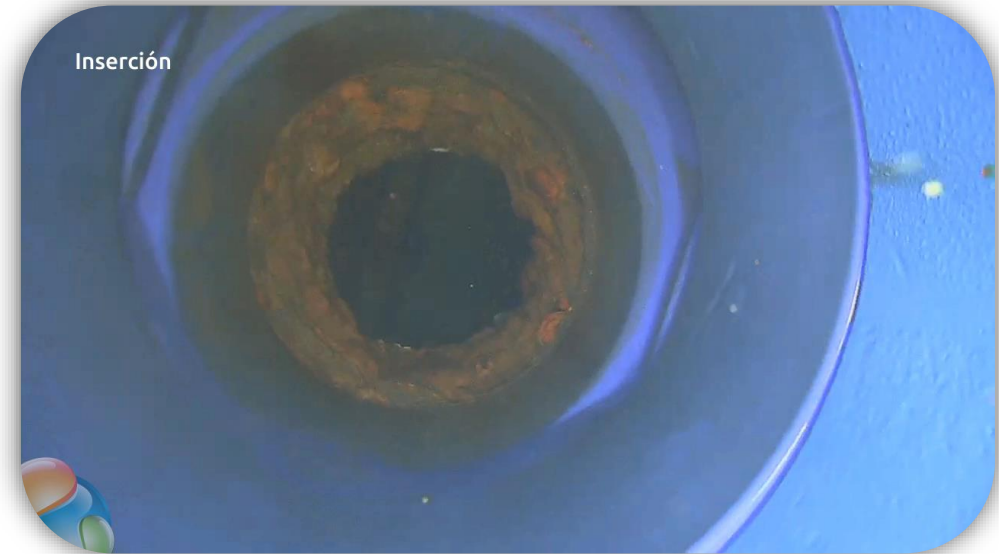
# Jabega System

Visual and acoustic technology to obtain detailed information from the interior of the pipe.

Pipe visualization system from the inside for the detection and identification of anomalies.

It has a high intensity hydrophone that allows acoustic recording inside the pipe and, therefore, the detection of leaks and existing anomalies.

It allows to know the route of the pipe to be able to follow Jabega from the surface.

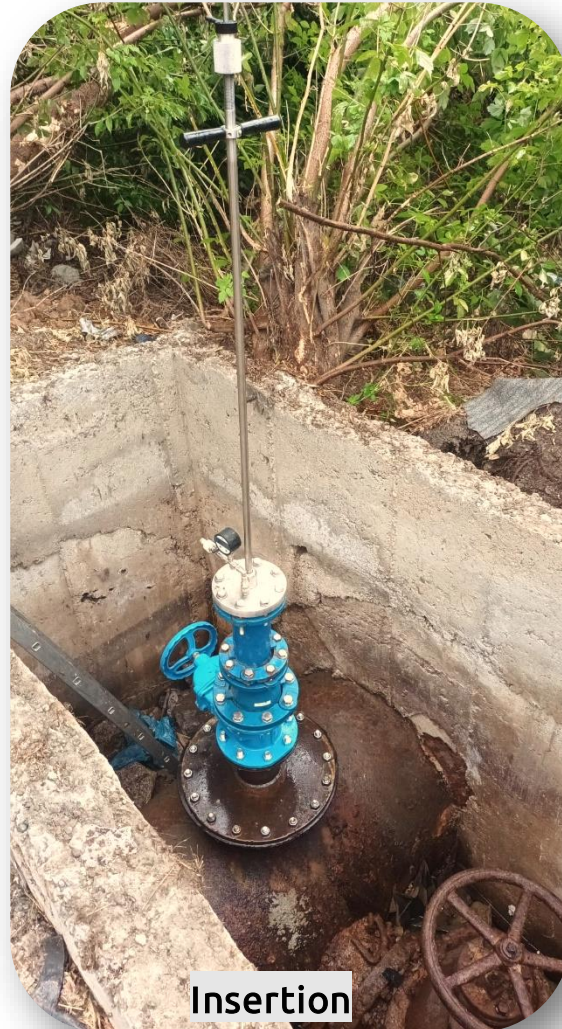
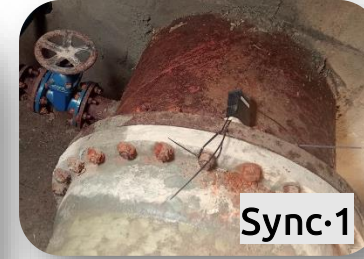
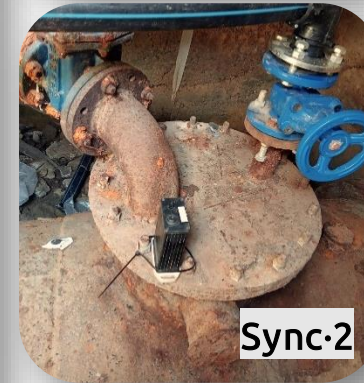
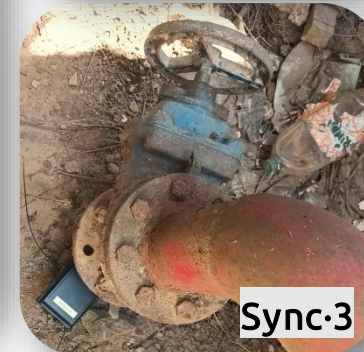
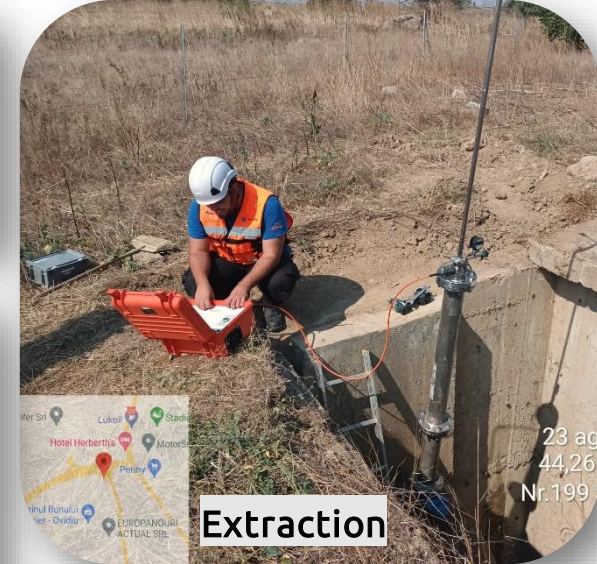
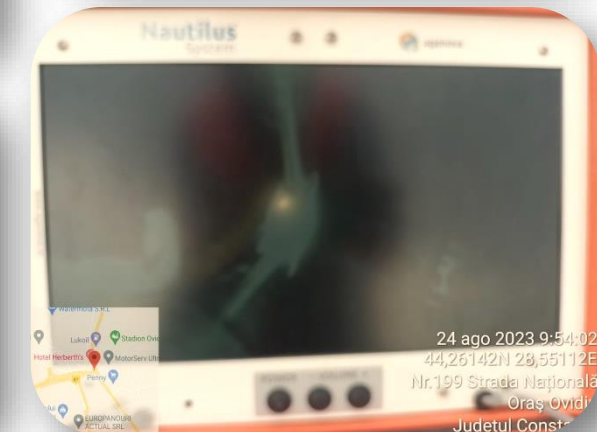
Operating gate valve DN150 mm. Pressure chamber with insertion clamp installed and Nautilus deployed according to planning schedule.

11 synchronizer have been prepared along the 8,8KM pipeline run. Each one at an AVG of 800 meters from each other to achieve maximum accuracy.

Installed on operating gate valve DN100 mm. Net position confirmed with in-line camera footage.

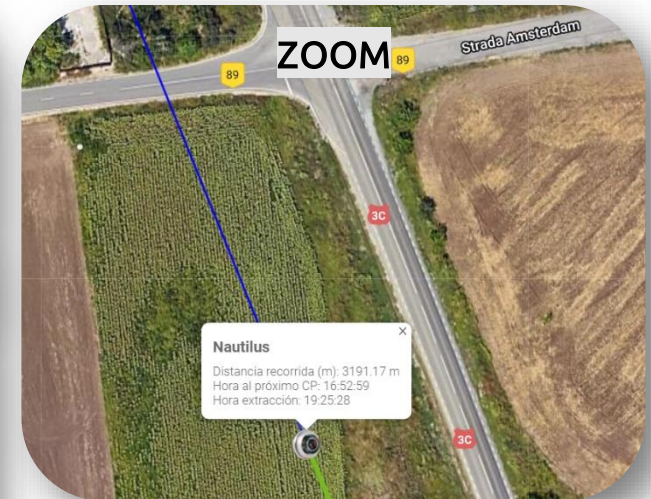
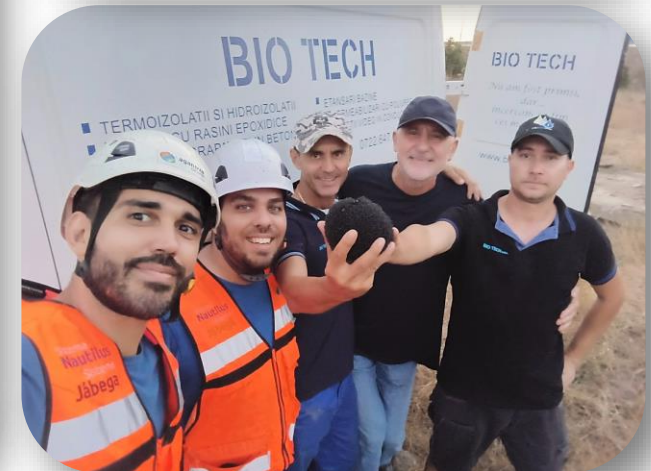
## NAVIGATION

Nautilus **started navigation at 13:21**. Confirmation signal received thought CP1 and later at **CP2 at 17:47** achieving 60% (5191 meters) of the total navigation. **ETA to extraction point at 19:25**.

Nautilus has **arrived at 19:32** at the extraction point as planned.

**Total navigation 6 hours, 11 minutes** for 8,8KM run at 0,4 m/s AVG water speed.

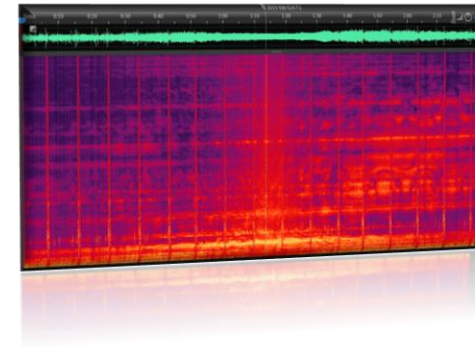
Nemo  
Platform

After 3 days analysis preliminary report shows a total of **15 incidents** found, **12** of them are **leaks** which **5 are big leaks**.

Incident level	Leak			Air		Anomaly	
	F1	F2	F3	B1	B2	A1	A2
15 Incidents	5	1	6	1	1	1	0
