Managing Large Diameter Pipelines

A proactive approach

ING. MICHAL SKALICKÝ
SALES ENGINEER, XYLEM

WATER LOSS FORUM
SEPTEMBER 1, 2023

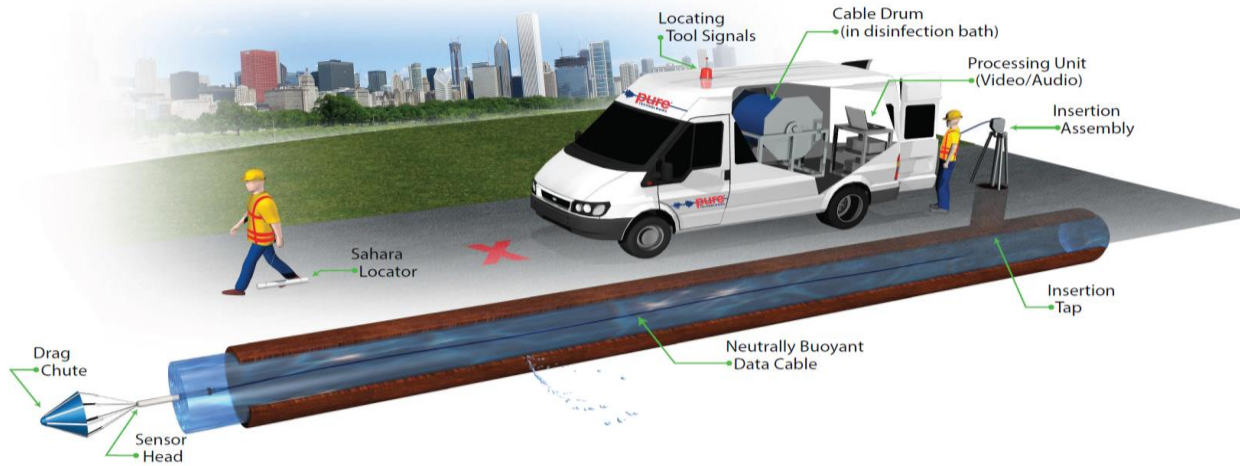
Sahara® System

- Tethered leak detection with CCTV
- Ideal for complex networks
- Worldwide since 1999

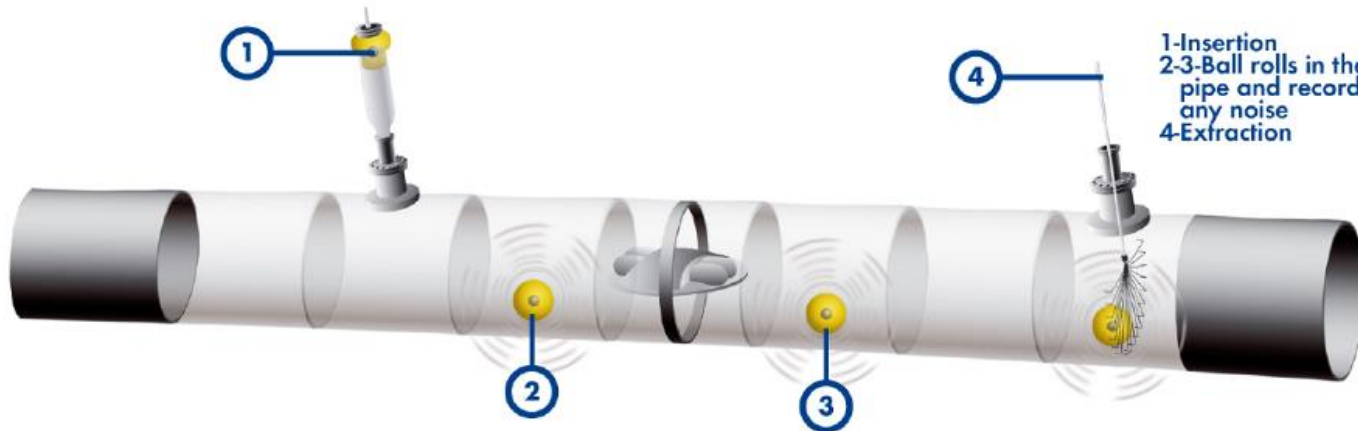
SmartBall® System

- Free swimming system
- Ideal for long transmission mains
- Worldwide since 2005

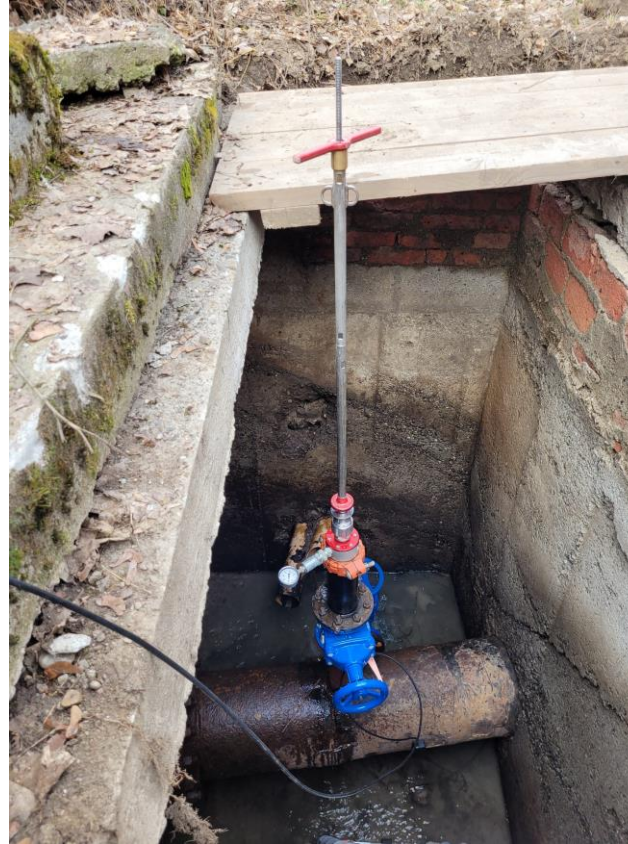
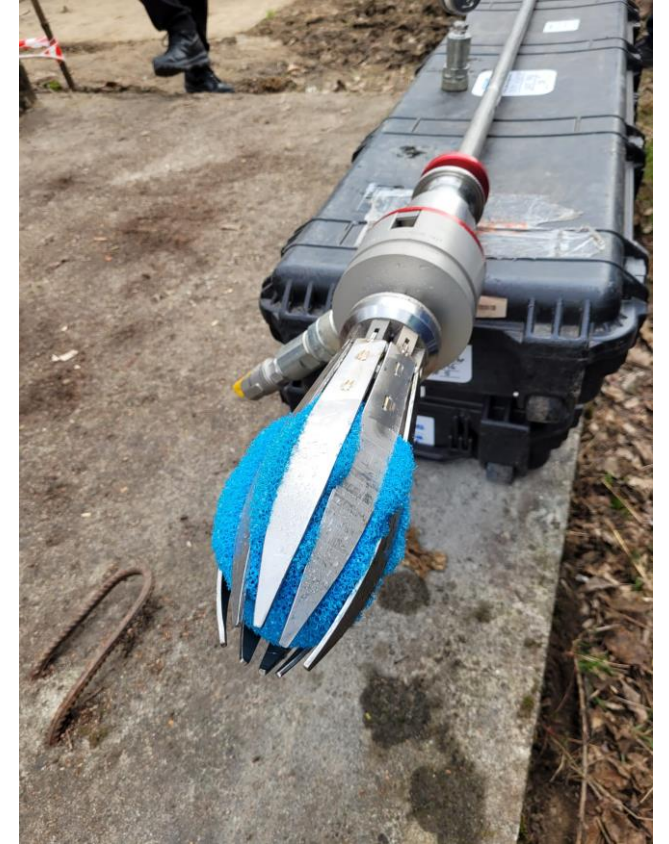
1st SmartBall project in Romania

- Compania Aquaserv Targu Mures
- 6.15km long DN 400 Steel pipeline
- Insufficient flow
- Suspected blockage

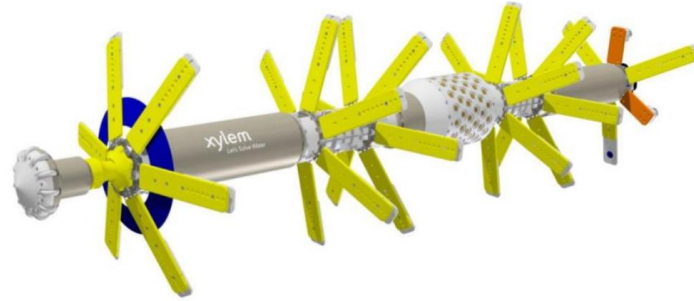
PipeDiver® System

- Free-swimming inline tool
- Minimum disruption to service
- Concrete and metallic pipelines

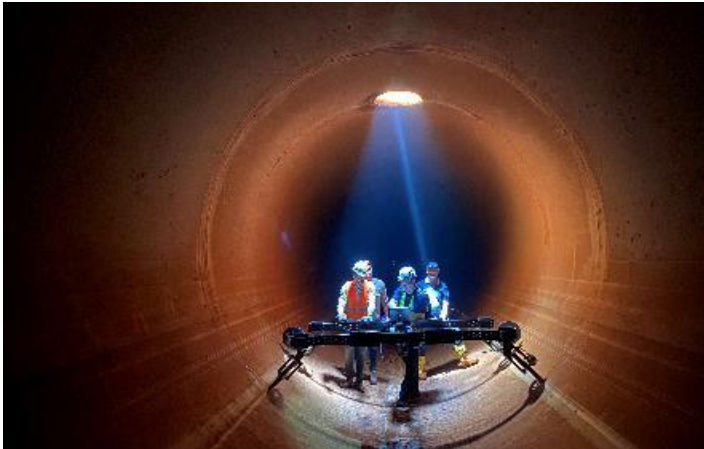
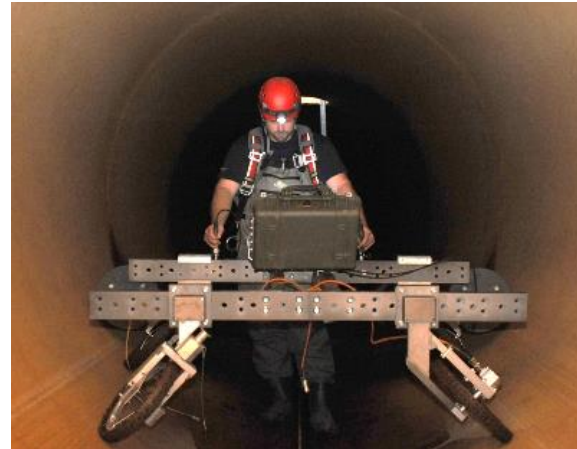
PipeWalker® System

- Worker operated tool
- Dewatered and depressurized
- Concrete and metallic pipelines

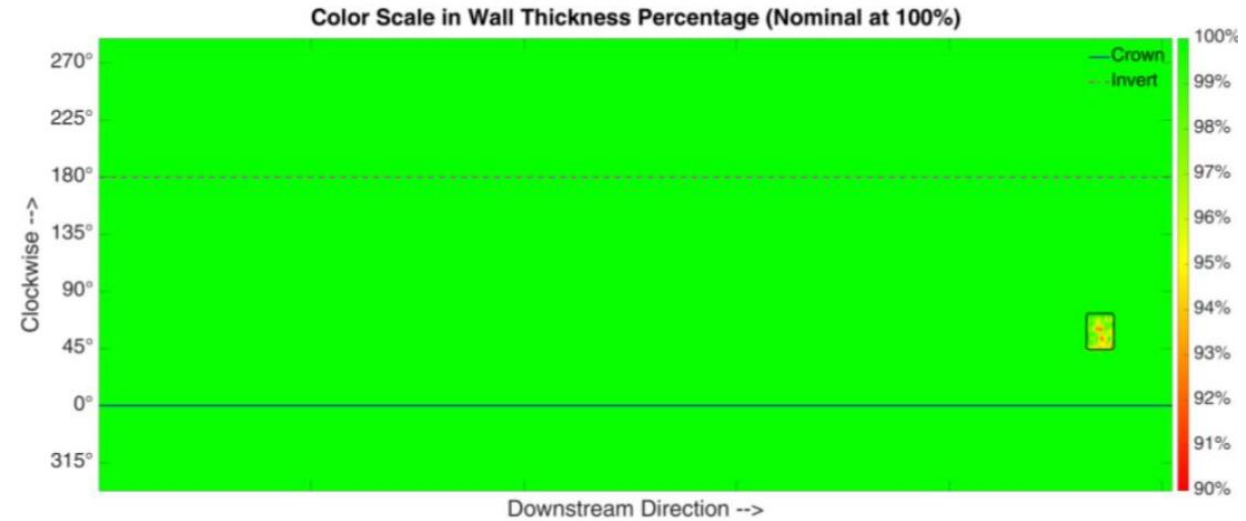
PipeDiver Metallic Detection capabilities

- Detection of wall loss areas as small as 50x50mm with 20% material loss
- Up to 12 hours of inspection time on single insertion
- 360° onboard Camera recording of the Pressurized or depressurized insertion and extraction of the tool

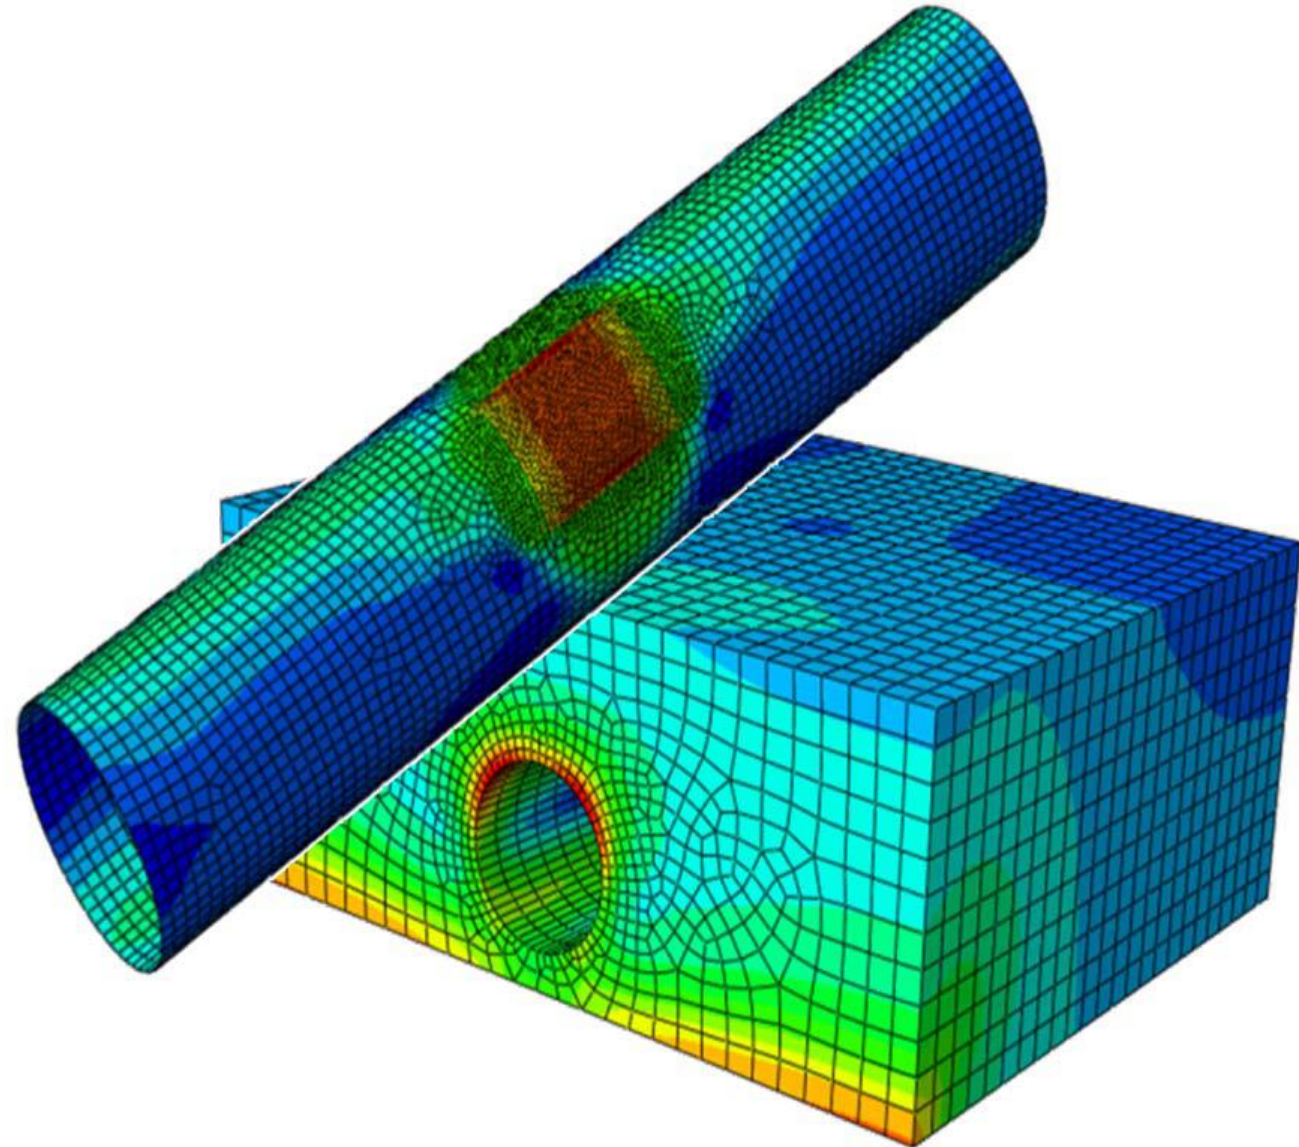
PipeDiver Concrete Detection cap

- For PCCP, PCP or BWP pipelines
- Excellent scanning reliability, proven principle
- Detection for up to a single broken wrap
- Pressurized or depressurized insertion and extraction of the tool
- Engineering report to determine failure point for each individual damaged pipe segment

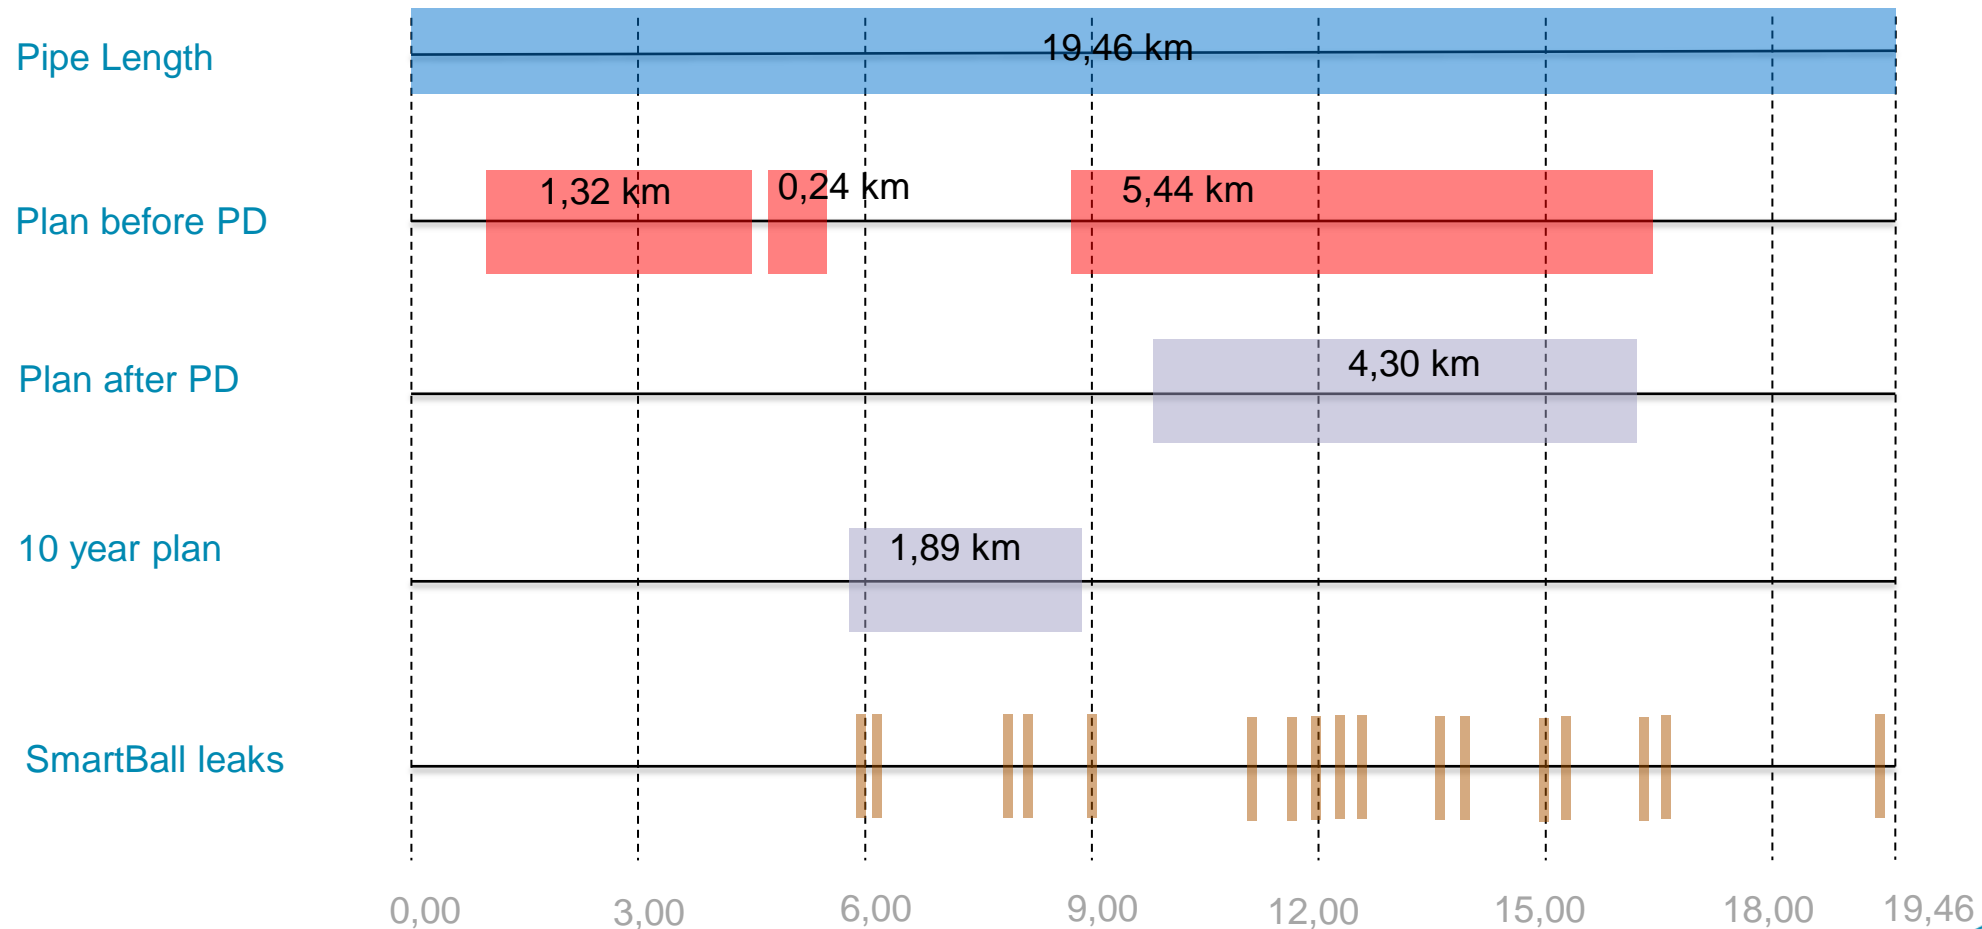
PipeDiver – Case study

Decision-making Results with PD:

- Immediate investments dropped by 38% - 2,49km
- 66% has remaining lifetime of 20+ years
- Dramatic changes to investments for next years

Renewal Now	Renewal Within 10 years	Renewal Within 20 years	Total --
Original investment plan	6,99 km	12,47 km	--	19,46 km
New investment plan	4,3 km	1,89 km	13,27 km	19,46 km

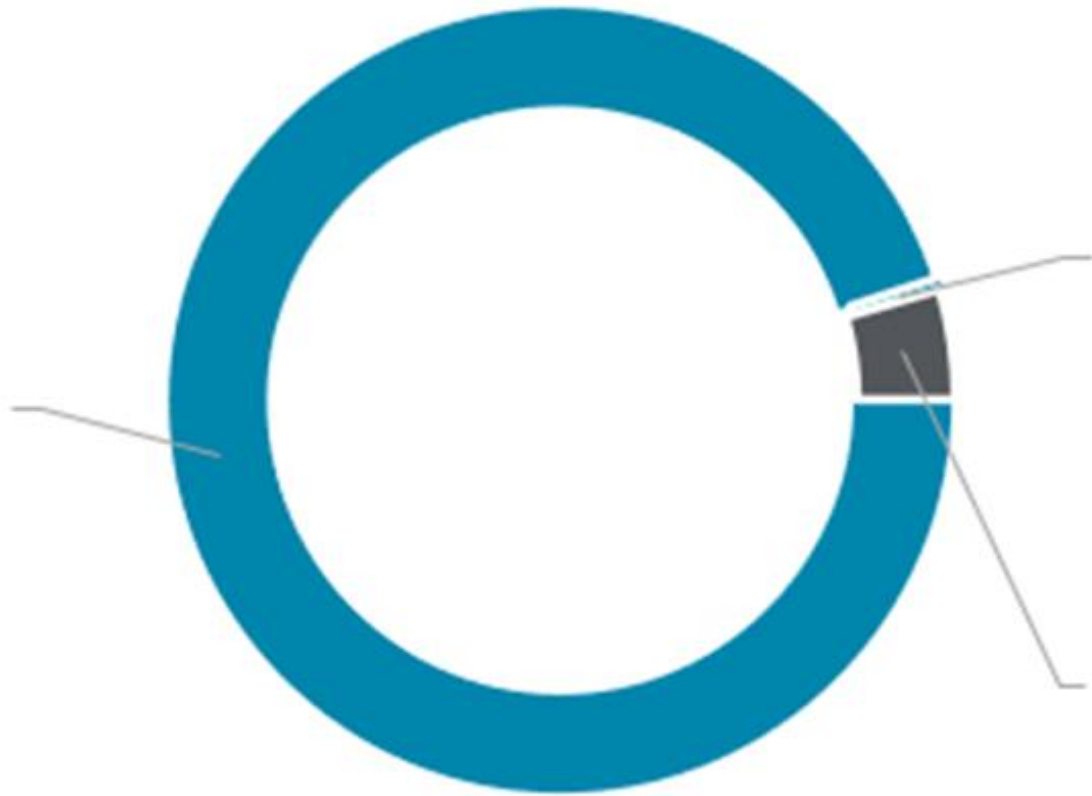
PipeDiver - Results

2,728 Pipes with no defects

where 384 pipes have out-of-roundness >5 %
- and where the 17 leaks are located

14 Pipes with defects

where 2 pipes have maximum out-of-roundness >5 %

130 Pipes with unfavourable liner

where 6 pipes have out-of-roundness >5 %

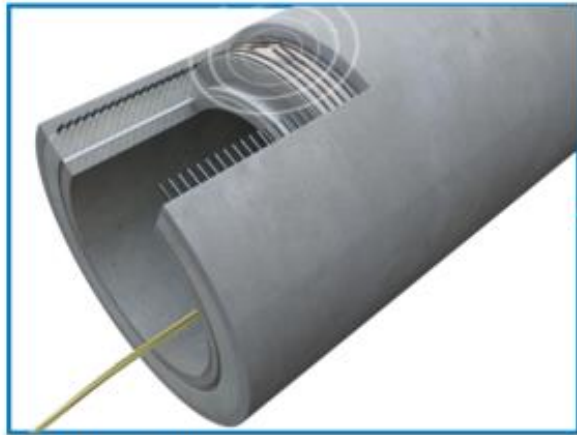
1. Wire fails

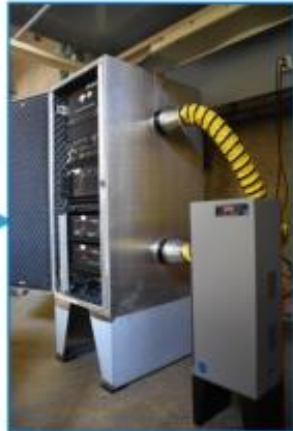
2. DAQ captures event

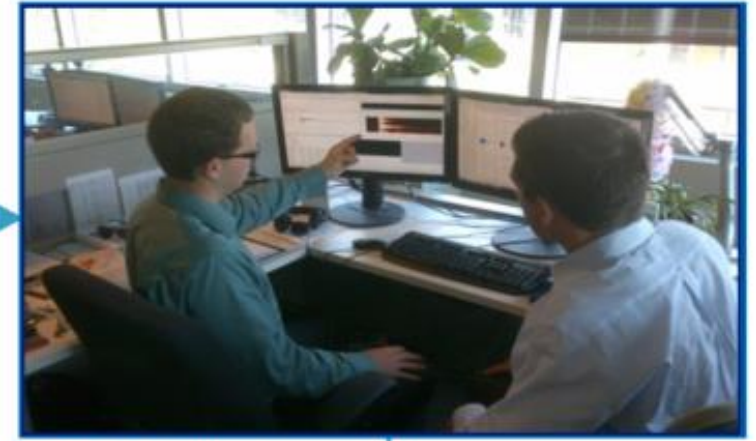
3. Data analyzed

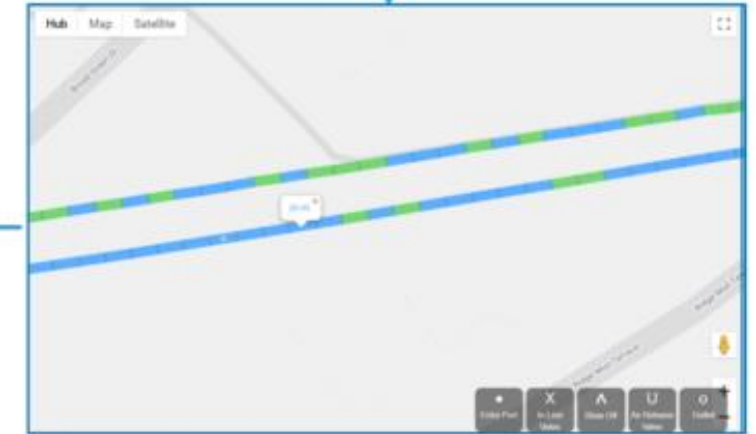
4. Reviewed & location mapped to pipe

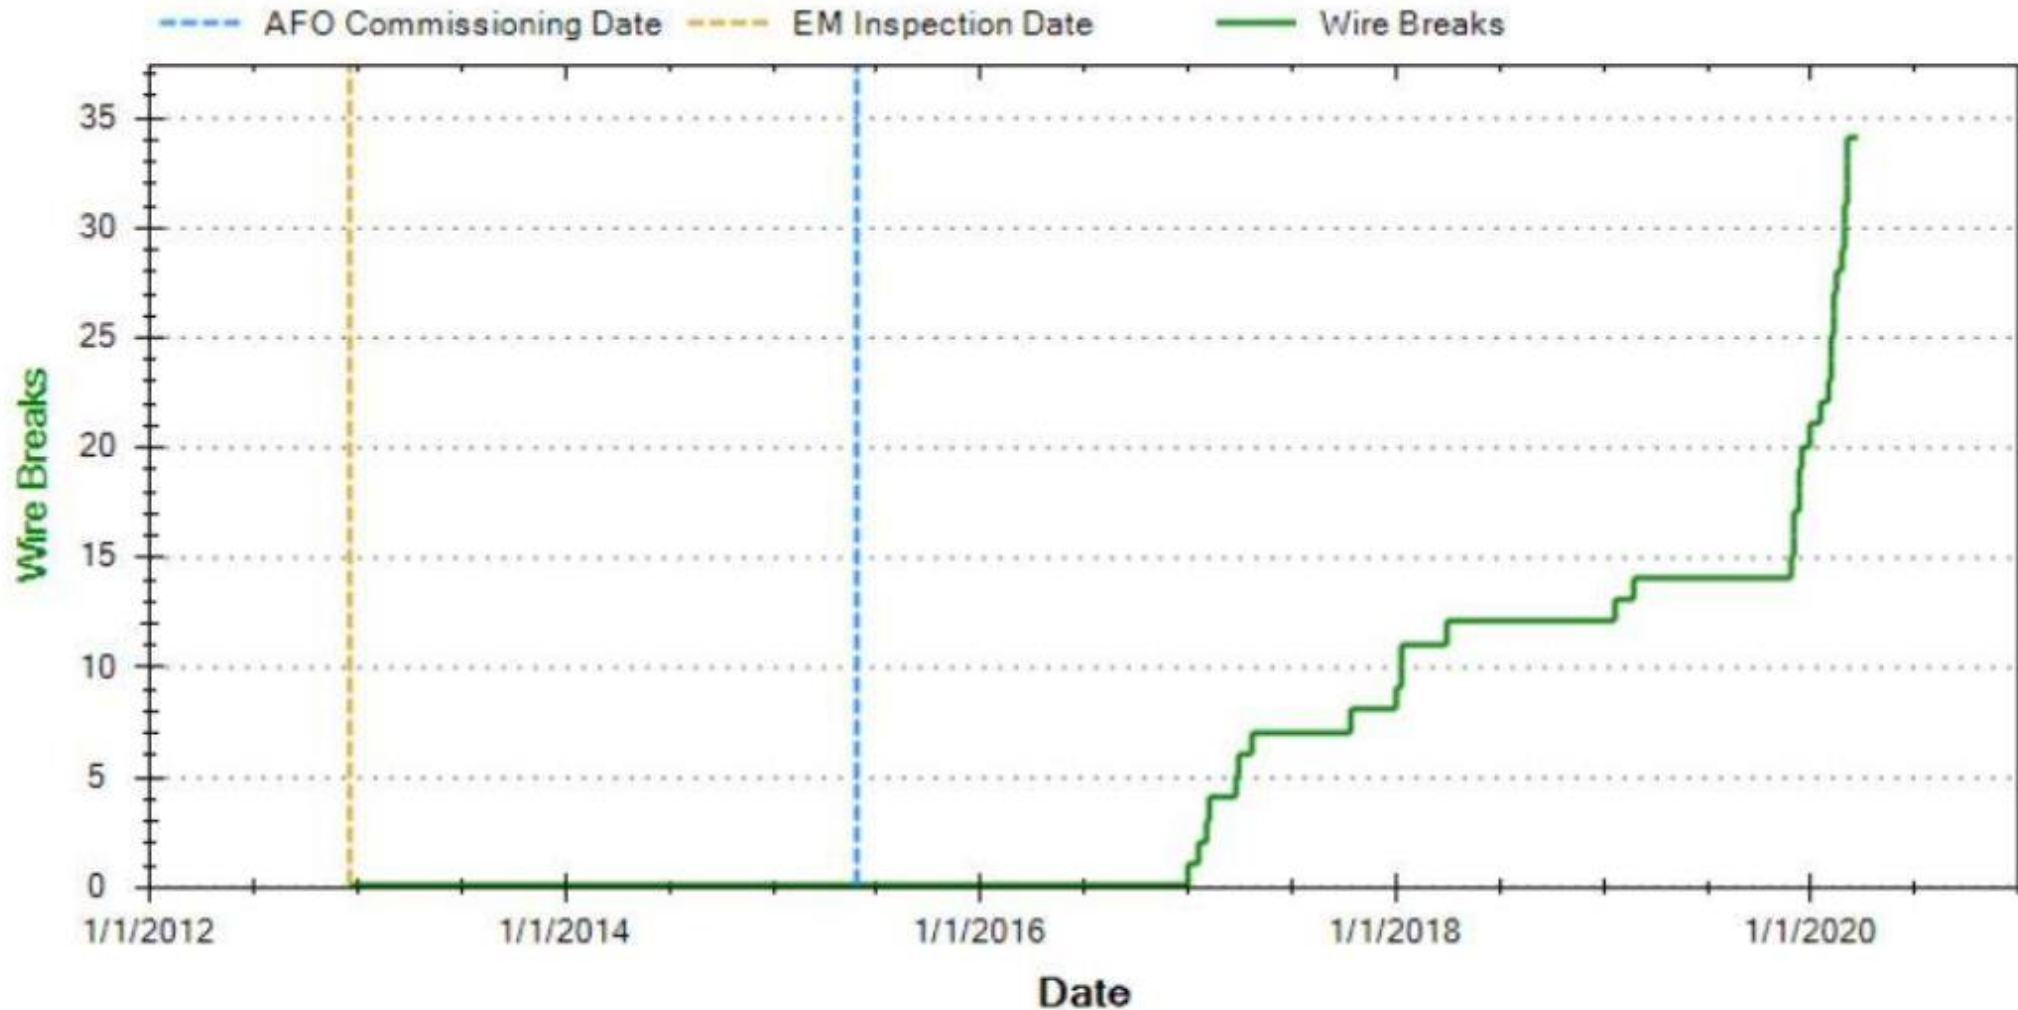
AFO Case Study – Long Term Monitoring Prevents Failure

Wire Break Trend
